Progress Report No. 12

Factor 9 Home: A New Prairie Approach

January 31, 2007

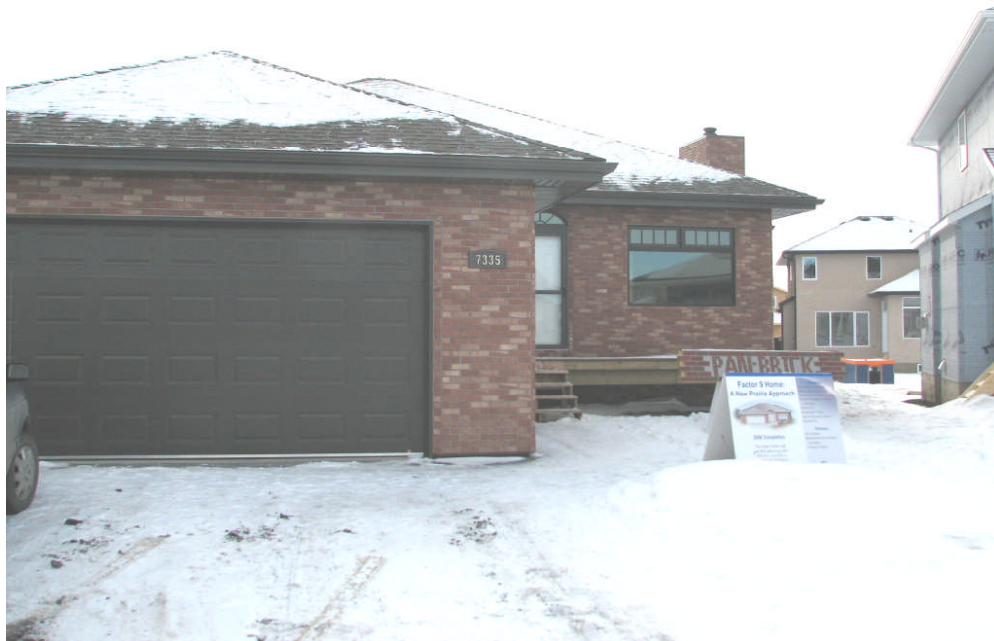
Figure 1. View of the Factor 9 Home from the North. January 25, 2007

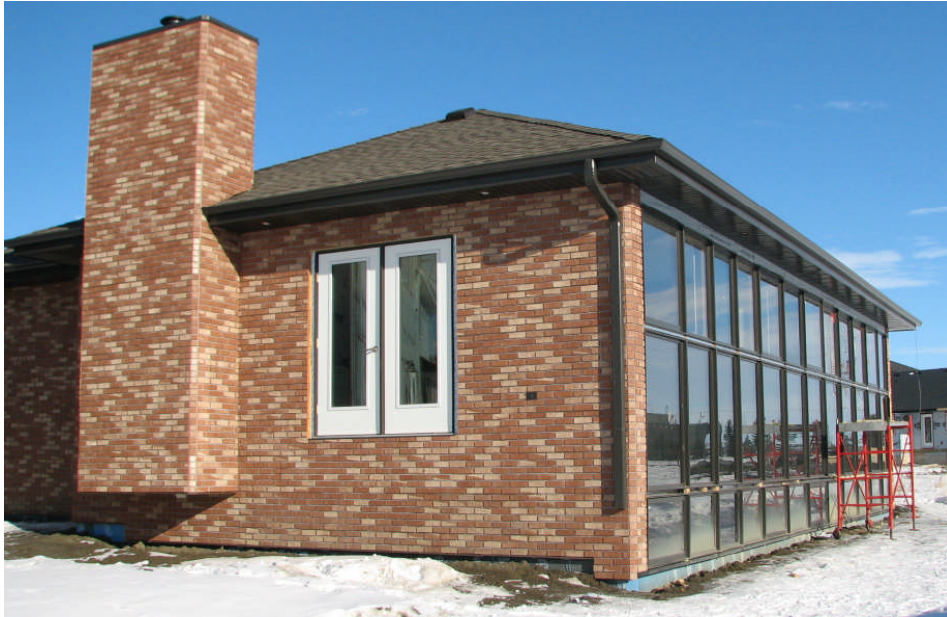
Figure 2. View from the southwest. The active solar thermal panels are in a 5 foot tall horizontal band between the upper and lower windows on the south wall of the house. Note that the eavestrough and downspout are installed. The downspout water will be piped into the flexible bladder storage tanks located beneath the basement floor. This stored water will be used for toilet flushing and exterior non-potable uses.

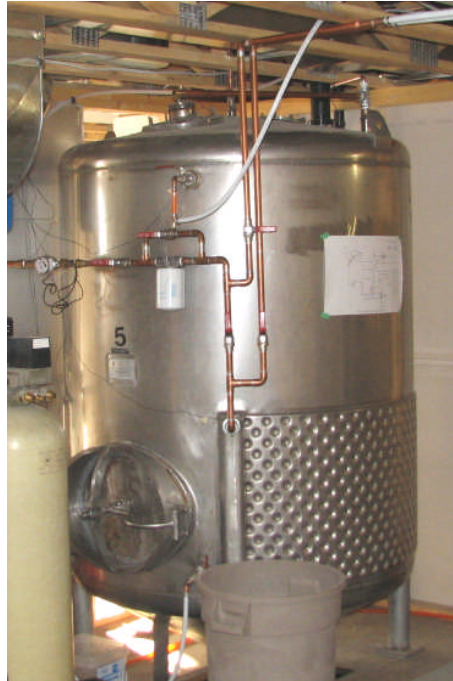
Figure 3. Heat storage tank for the solar heating system. The tank has a volume of 517 imperial gallons (2347 litres) Note the wrap around heat exchanger on the lower right half of the stainless steel tank. The glycol solution from the solar panels transfers heat to the tank via this heat exchanger. In an earlier life this tank was used in a brewery.

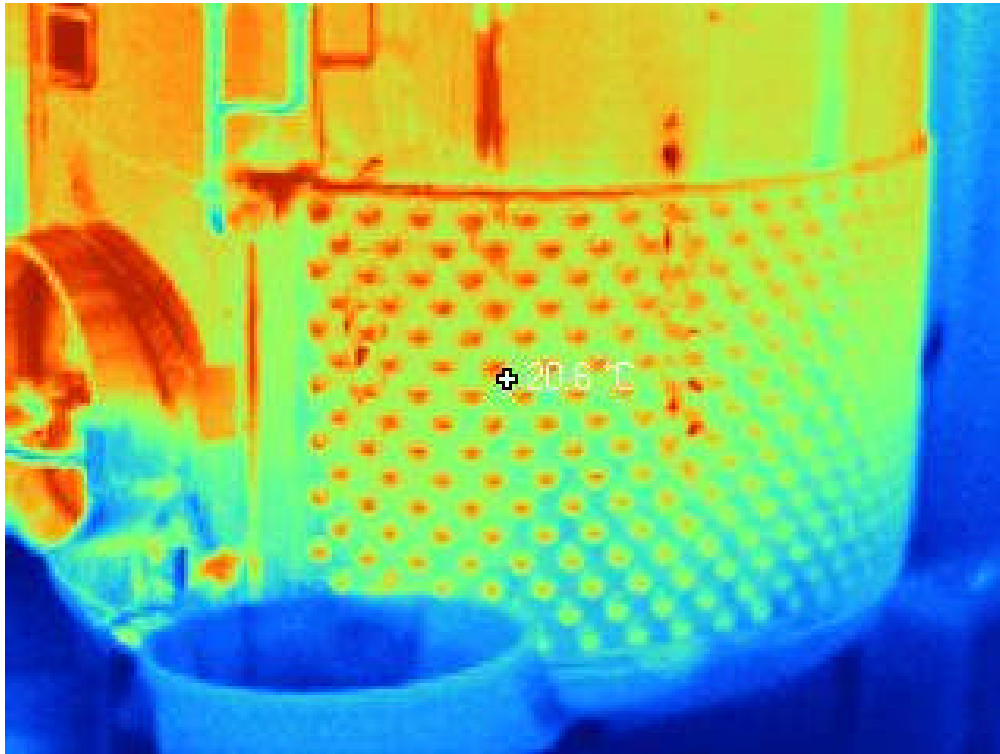
Figure 4. Infrared photo of the heat storage tank. Note the cool blue colour at the base of the tank, and warmer red colour as one moves up the tank. The tank will be insulated with sprayed polyurethane insulation.

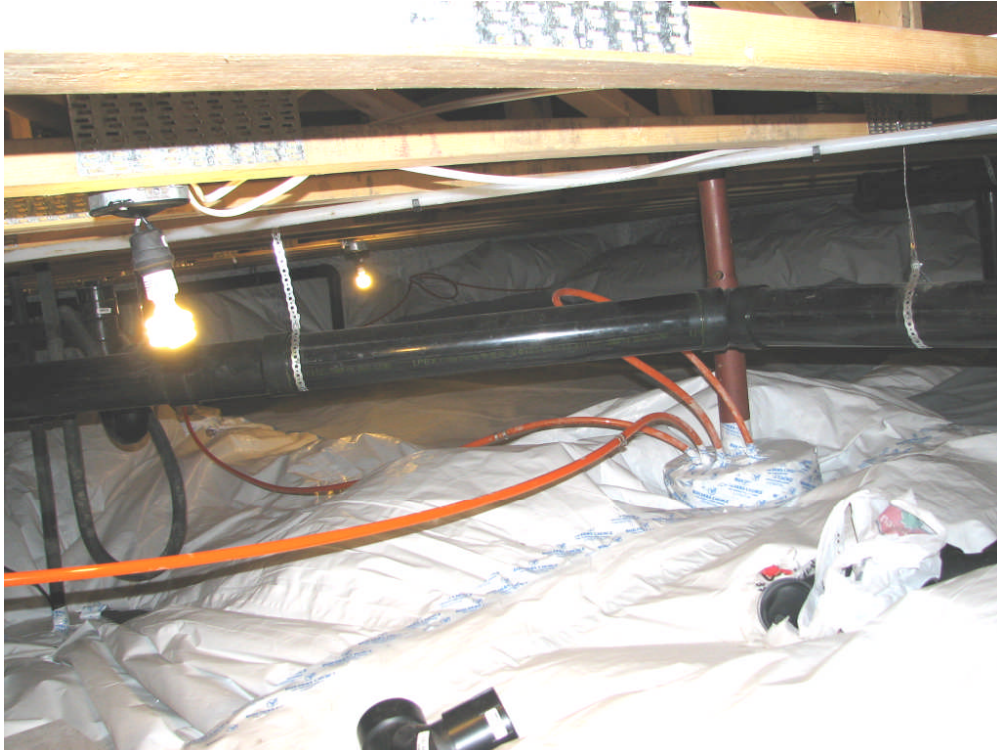
Figure 5. View of the crawl space beneath the basement floor. A very high degree of air sealing was accomplished with the ground cover membrane. This excellent air sealing will be valuable in limiting radon gas entry into the living space. The orange pipes are the plastic pipes that will extract cooling from the concrete pilings that support the house.

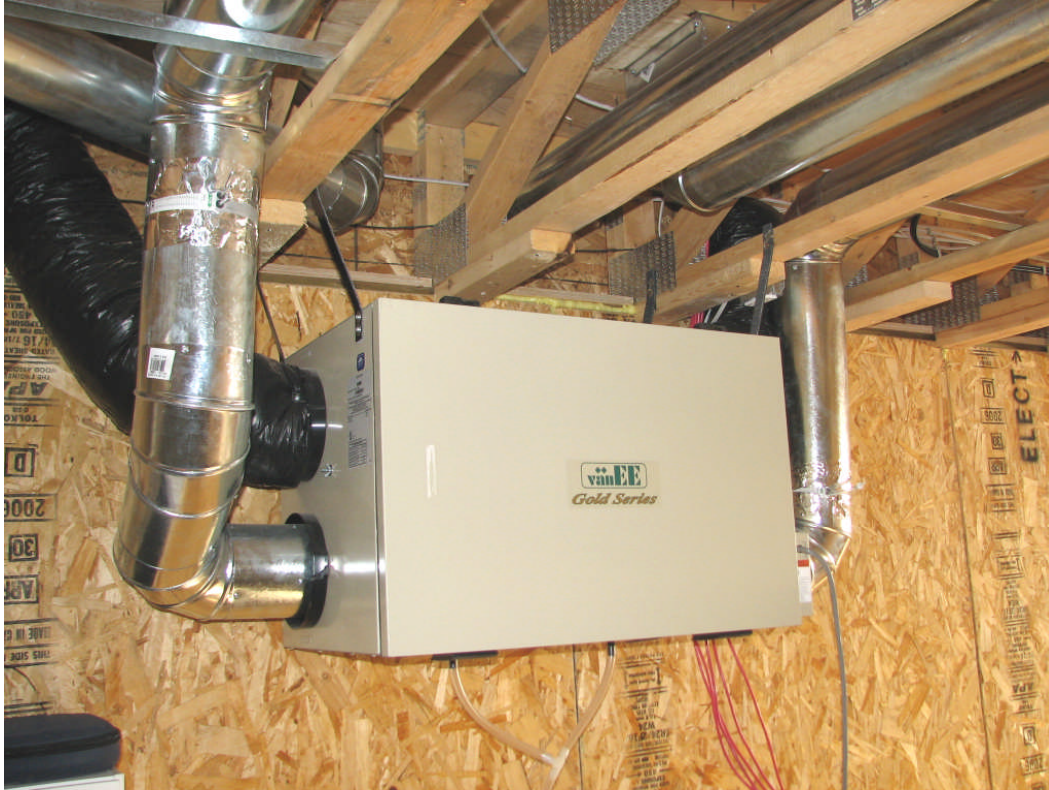
Figure 6. Air to air heat exchanger for the house. The unit is located near the outside wall to minimize the length of the insulated ducts to and from outside. The exchanger pulls exhaust air from the bathrooms, laundry area and kitchen, and exhausts to the outside. The outside air that passes through the exchanger is ducted into the return air side of the air handler for the house.

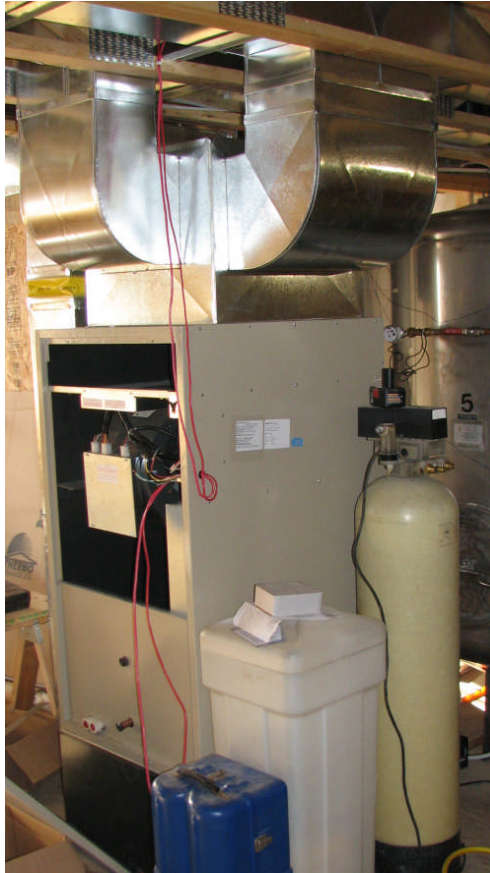
Figure 7. Air handler for the house. The unit has a brushless DC fan motor. An A coil (water to air heat exchanger) is located in the lower part of the unit. The unit provides space heating by taking hot water from the large storage tank. In the cooling season, it will take cool water from the piping embedded in the concrete piles and the grade beam.

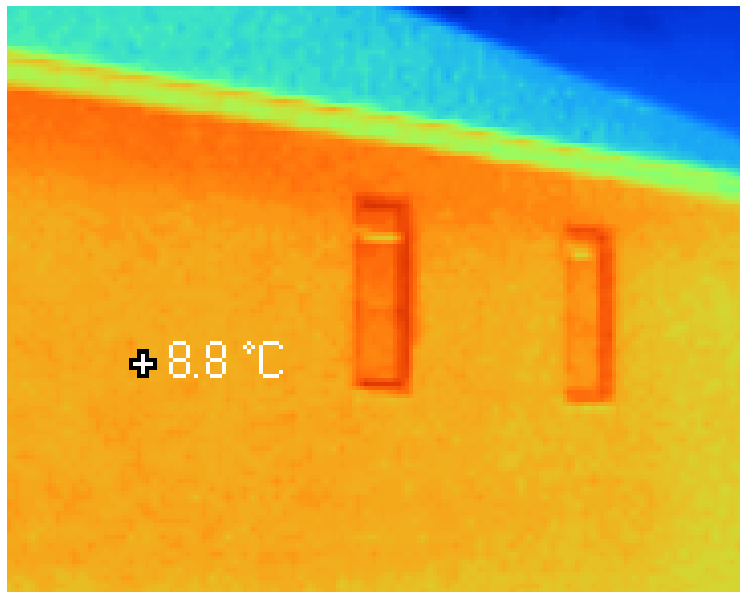
The infrared photo in Figure 8 is of the east wall of the Factor 9 home. The uniform colour on the walls is indicative of the absence of thermal bridges.

Figure 8. Infrared photo of the east wall of the Factor 9 Home. The two windows are in the master bedroom.

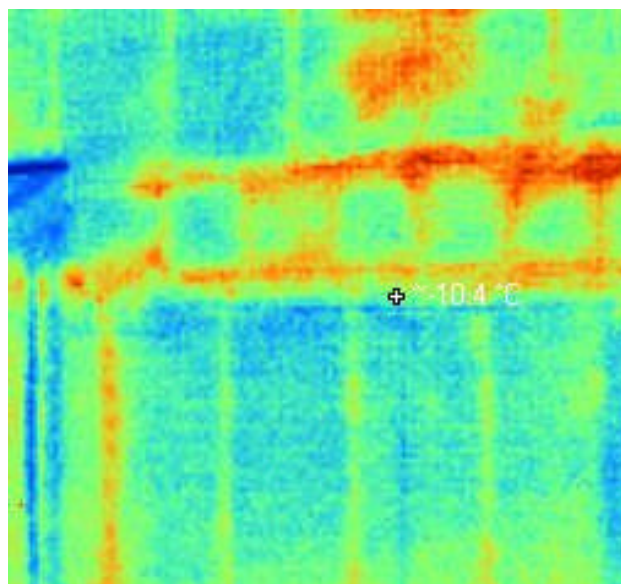
Figure 9. Infrared photo of the wall of a conventional home. Note the red spots indicating heat loss at the rim joist area. The house has two storeys.

The light coloured vertical lines are the wall studs. In addition to the heat loss by conduction, there is likely also some air leakage present at the rim joist area.
