**THE FACTOR 9 HOME:
A NEW PRAIRIE APPROACH
MONITORING
FINAL REPORT
Revision 1**

John Gusdorf
Natural Resources Canada

Rob Dumont
Building Performance
Alternative Energy and Manufacturing Division

SRC Publication No. 12155-2C08

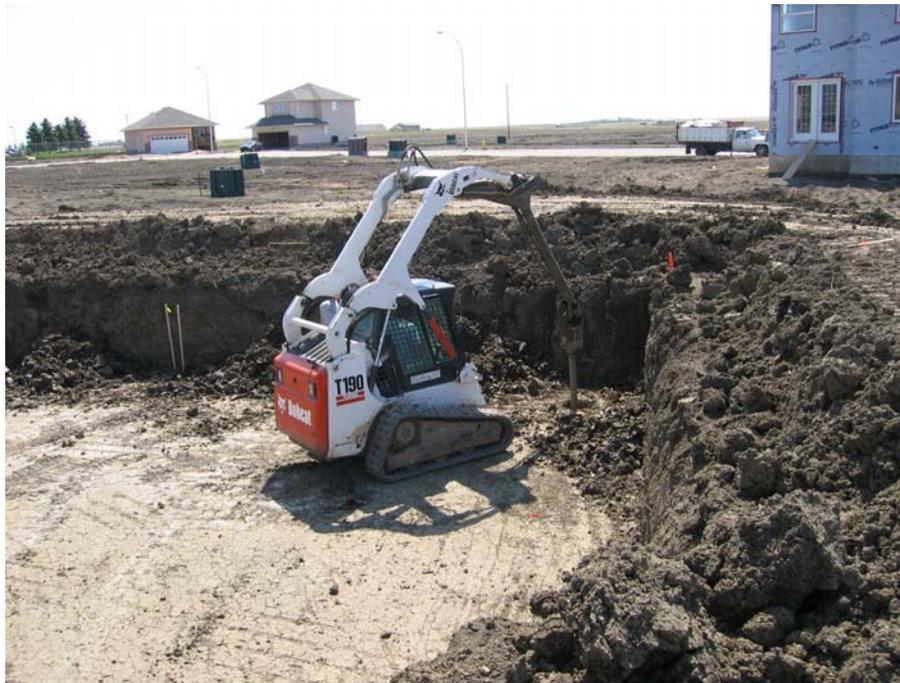
Figure 1: Basement excavation and drilling of the piles for the home

A photo of the basement excavation, taken in May 2006, is shown in Figure 1.

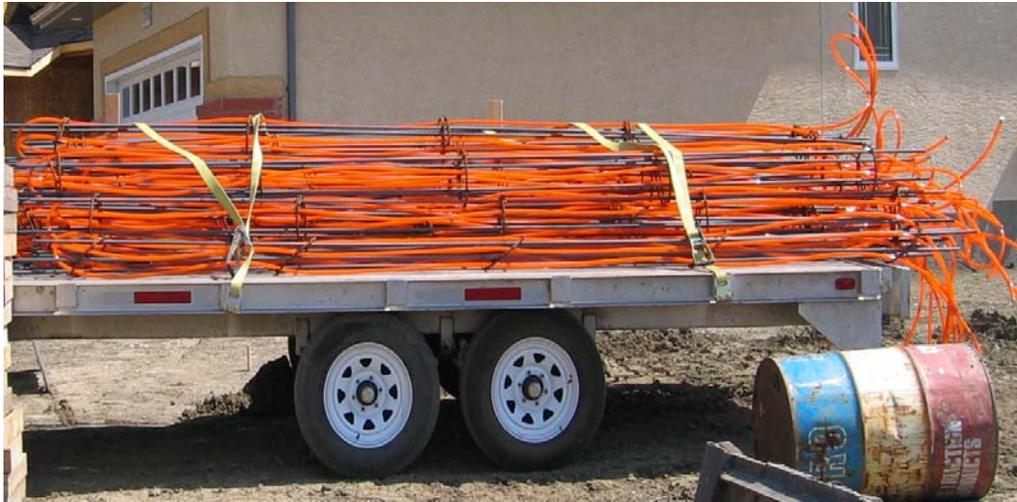
Figure 2: Rebar and plastic cooling pipes for the pilings

Placement of the cooling pipes in the piling holes. Figure 2 shows the steel rebar along with the plastic cooling pipes.

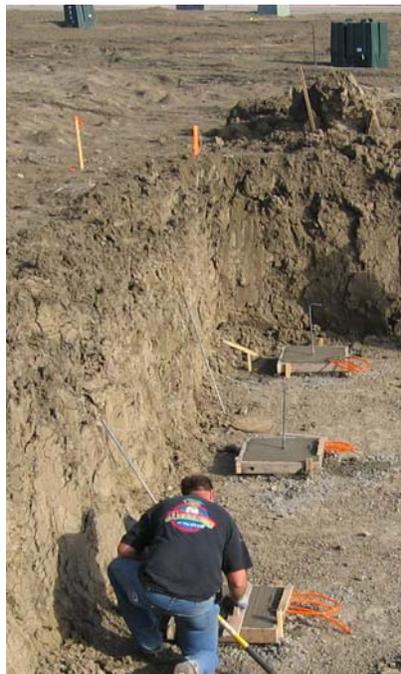
Figure 3: Leveling of the piling caps

A photo of the tops of the concrete pilings is shown in Figure 3. The orange plastic pipe is visible at the top of each pile. A total of two loops of plastic pipe were placed in each of the piles to extract cooling.

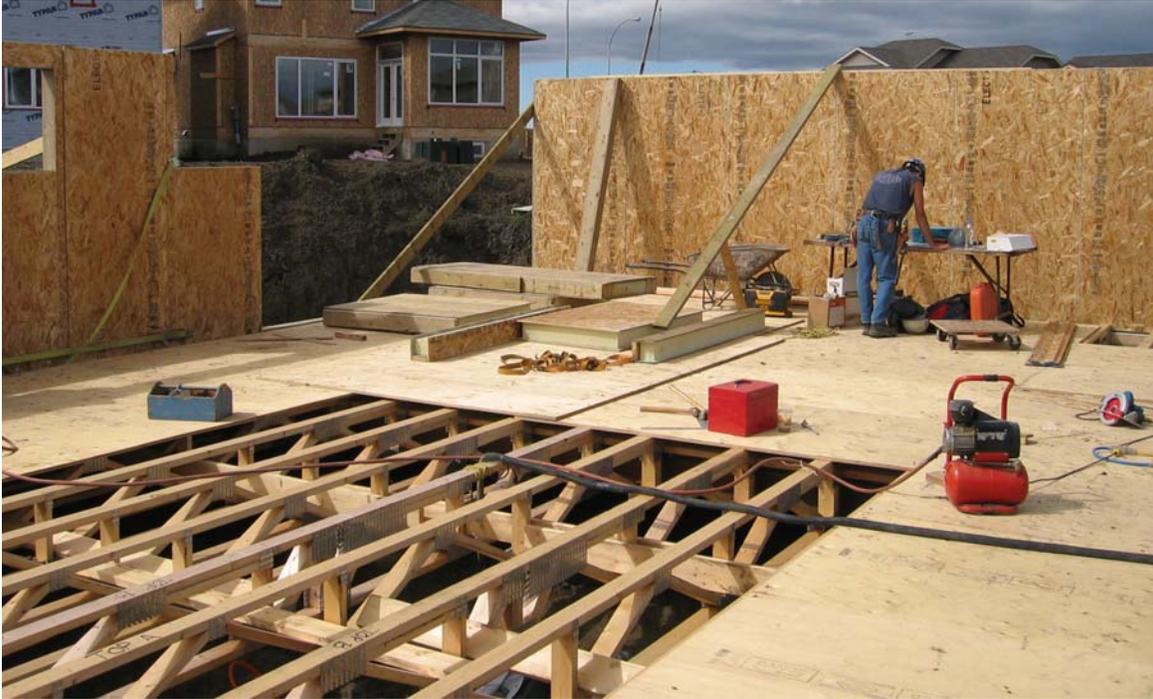
Figure 4: Basement floor with wood trusses

A concrete grade beam was placed on top of the pilings, and a wood truss floor used for the basement floor. A picture of the wood floor is shown in Figure 4. Some of the basement walls have been put in place. A generous crawl space is placed beneath the basement floor. Two membrane tanks have been placed in the crawl space for storage of water collected from the roof.

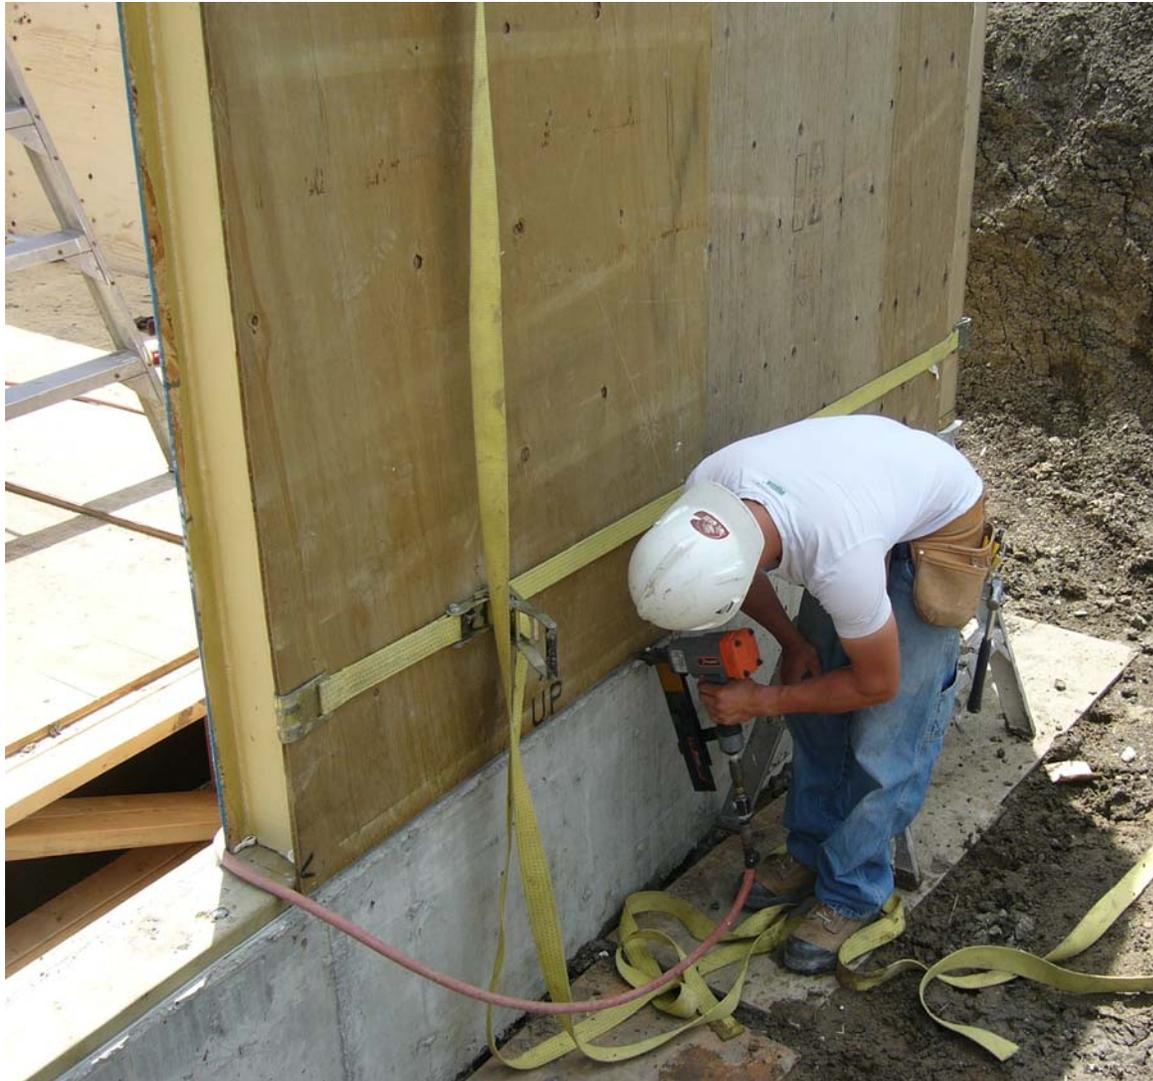
Figure 5: Concrete grade beam and the SIPs for the basement walls

The basement walls are structural insulated panels with polyurethane foam between the inner skin of oriented strand board and the outer skin of pressure treated plywood.

A picture of the basement walls being assembled is shown in Figure 5. The canvas straps are used to pull together the panels.

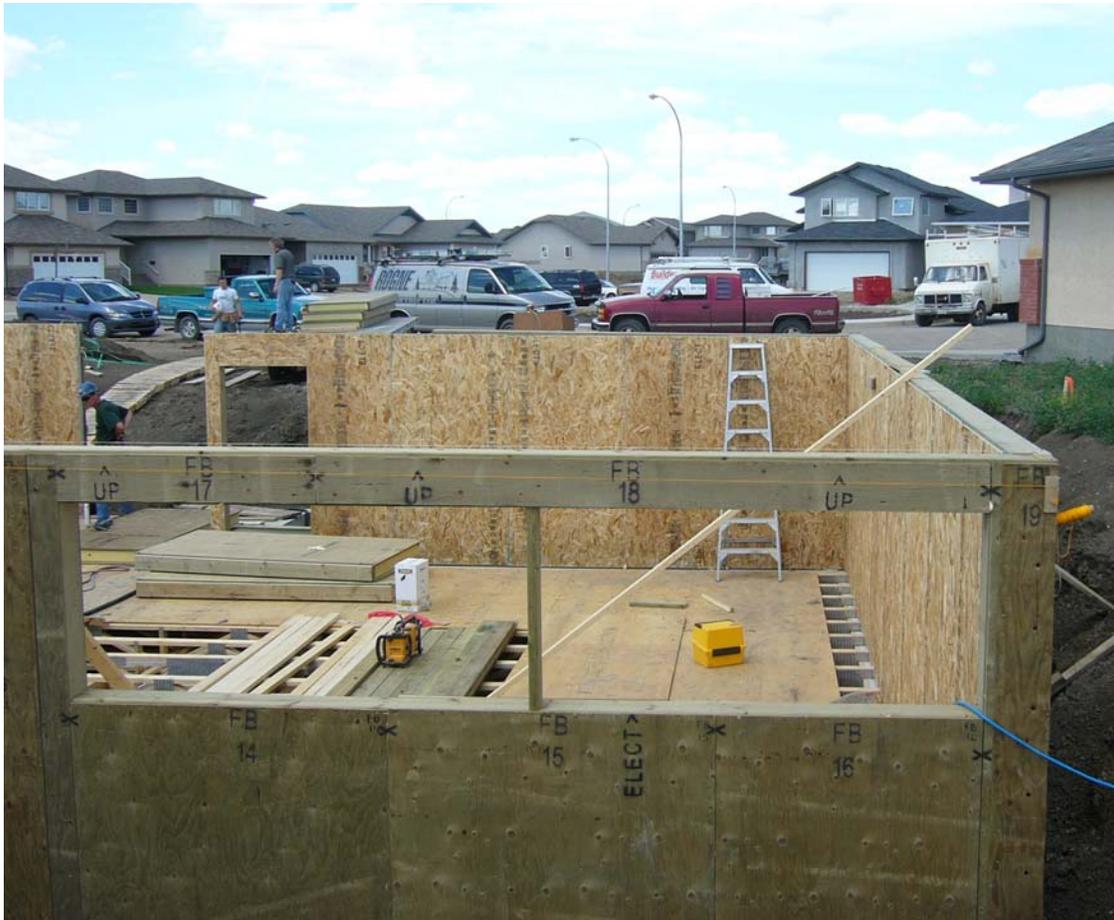
Figure 6: Basement walls and floor for the house

Another view of the basement walls and floor is shown in Figure 6. The window opening in the foreground is on the south side of the house.

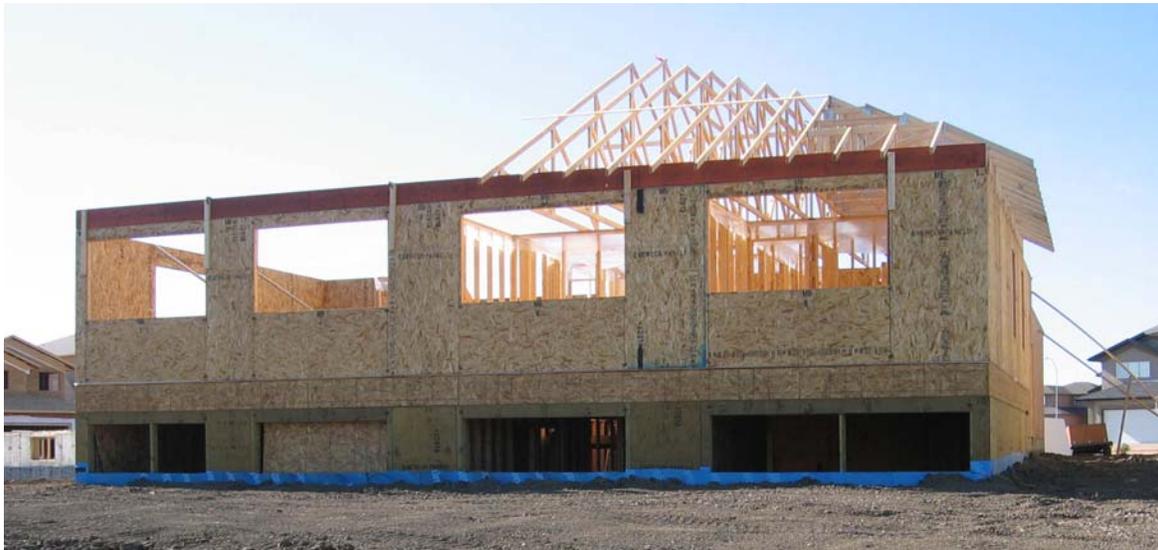
Figure 7: View of the house from the south

Structural insulated panels were also used for the main floor of the house. A view of the main floor walls is shown in Figure 7. The blue material on the basement walls is a peel and stick waterproofing membrane. Granular material was used as backfill for the basement walls to help avoid soil pressure loads from the expanding clay soil. High heel roof trusses were used to help accommodate the high attic insulation levels.

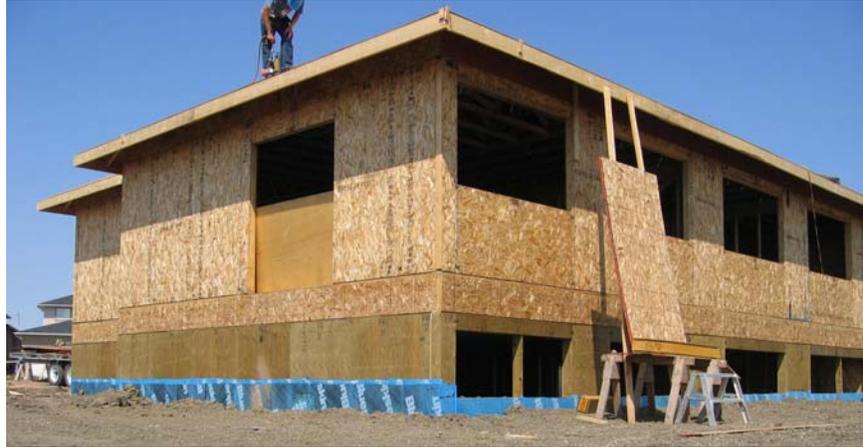
Figure 9: View from the southwest as framing is nearing completion

A view of the house near the completion of the framing stage is shown in Figure 9. This photo was taken August 6, 2006.

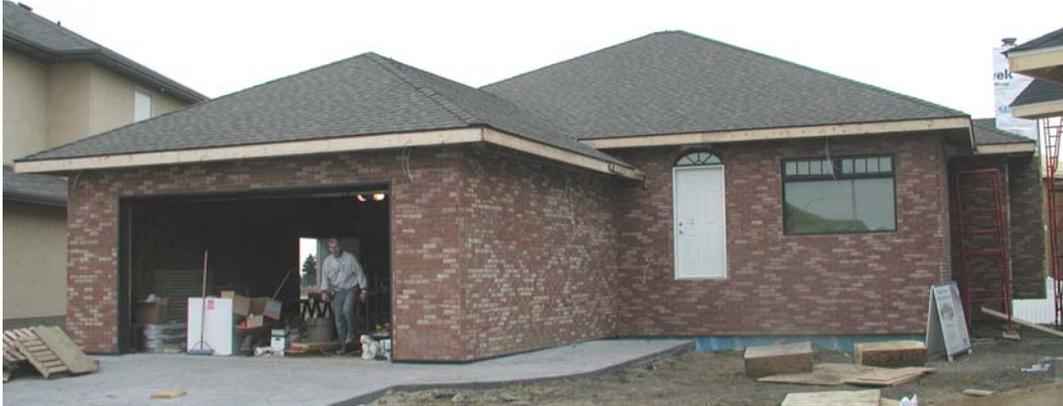
Figure 11: View from the north of the house

Upgraded asphalt shingles were used on the roof. A picture is shown in Figure 11. The asphalt shingles have been installed, along with the windows and exterior insulating brick.

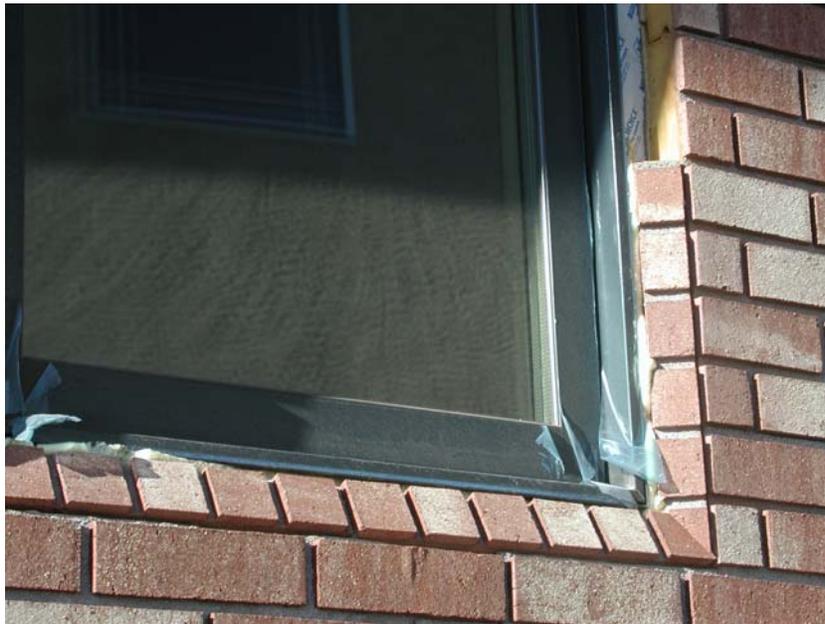
Figure 12: Window installed in an east-facing wall

A photo of a window installed in the East bedroom is shown in Figure 12. The East, West and North facing windows are triple glazed with two low emissivity coatings and argon gas fill. The windows have wood frames with aluminum cladding on the exterior for low maintenance.

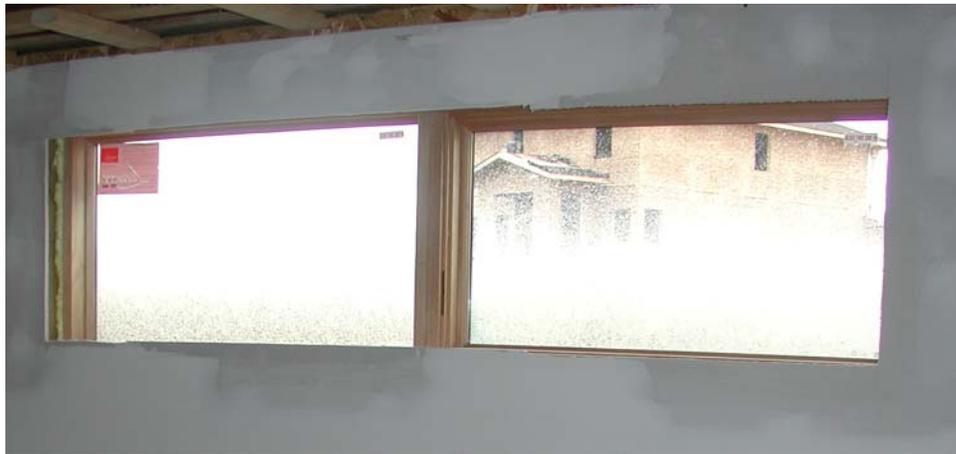
Figure 13: South facing windows in the basement of the house

A view of the inside of the windows is shown in Figure 13. These windows are in the basement in the approximate middle of the south wall. Note the wood frames for the windows.

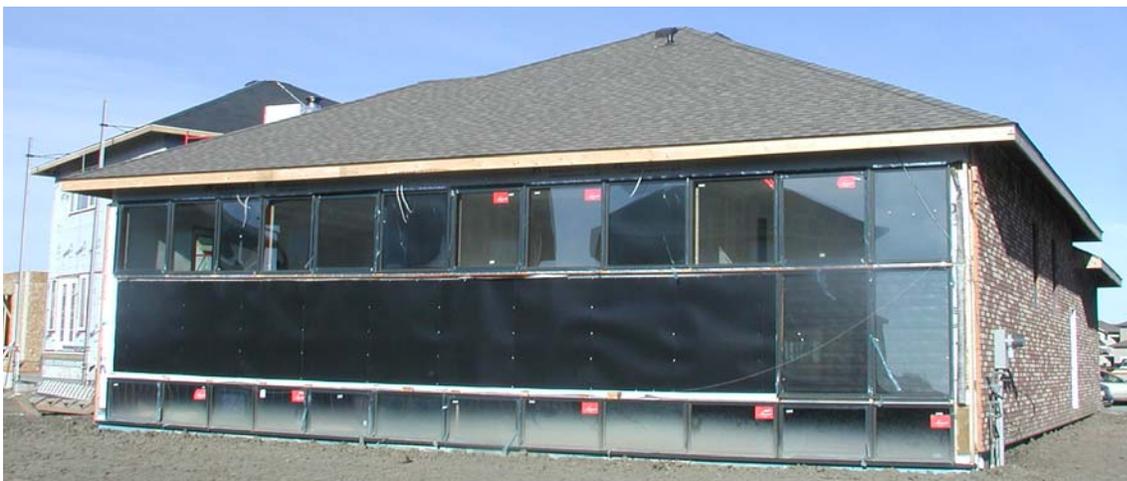
Figure 14: View of the south side of the house

The active solar heating panels were installed on the south wall of the house. A view of the south is presented in Figure 14. The active solar heating panels are being installed in a horizontal band between the lower windows in the basement and the windows on the main floor. Two of the glass cover plates for the solar panels are visible on the right of the wall.

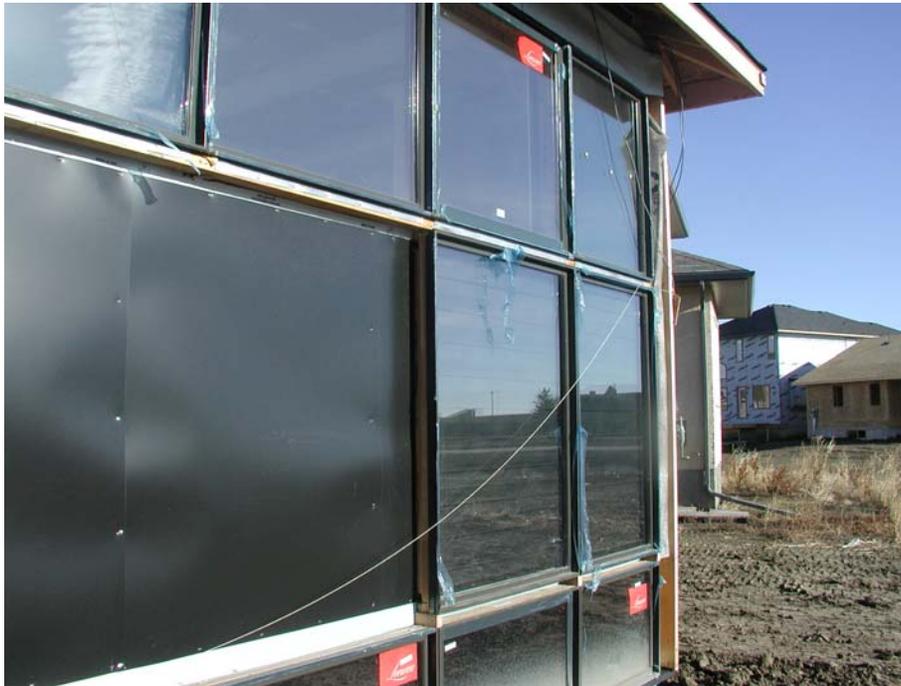
Figure 15: Active solar heating panels being installed

A closer photo of the active solar heating panels being installed is shown in Figure 15. The absorber plates are mounted on the vertical. Double glazing was used.

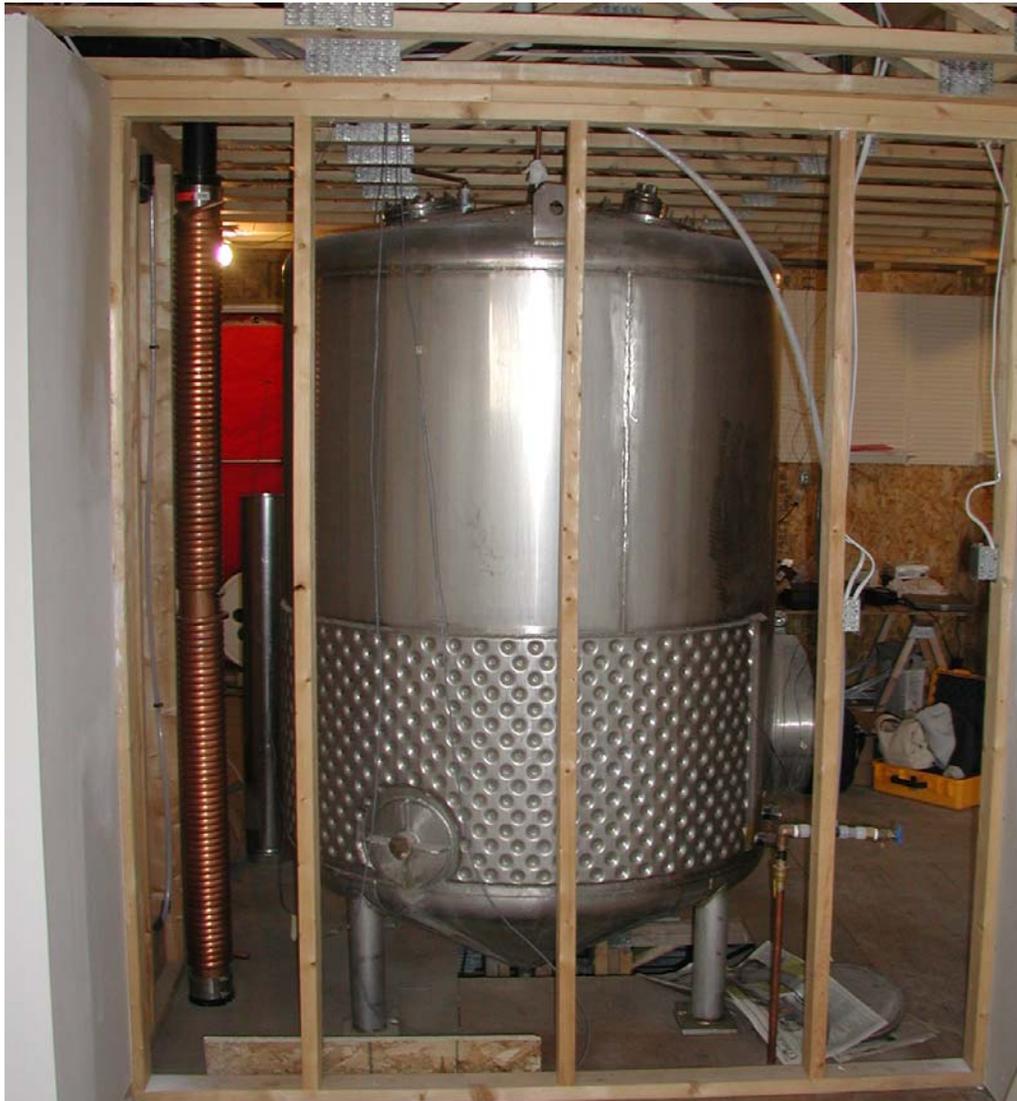
Figure 16: Stainless steel heat storage tank

A photo of the storage tank for the active solar heating system is shown in Figure 16. This 2350 litre tank is a recycled stainless steel tank originally used in a brewery. The lower part of the tank has a dimpled appearance. This lower part is the external heat exchanger on the tank through which the propylene glycol and water mixture passes.

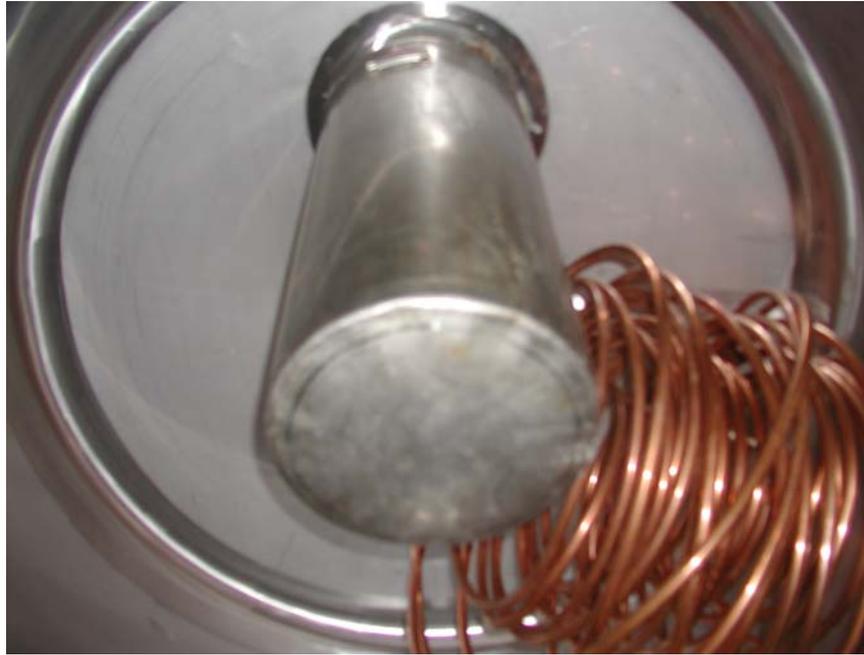
Figure 17: Small stainless steel tank and copper coil heat exchanger

The water in the tank is not used directly for hot water in the house. An immersed copper coil heat exchanger is used to transfer heat from the water in the large storage tank to the potable hot water. This copper coil heat exchanger is shown in Figure 17. The tank and heat exchanger were used to transfer heat from the water in the large storage tank to the potable hot water. The small tank was not hooked up. The large coil is used to ensure relatively good heat transfer from the water in the large tank.

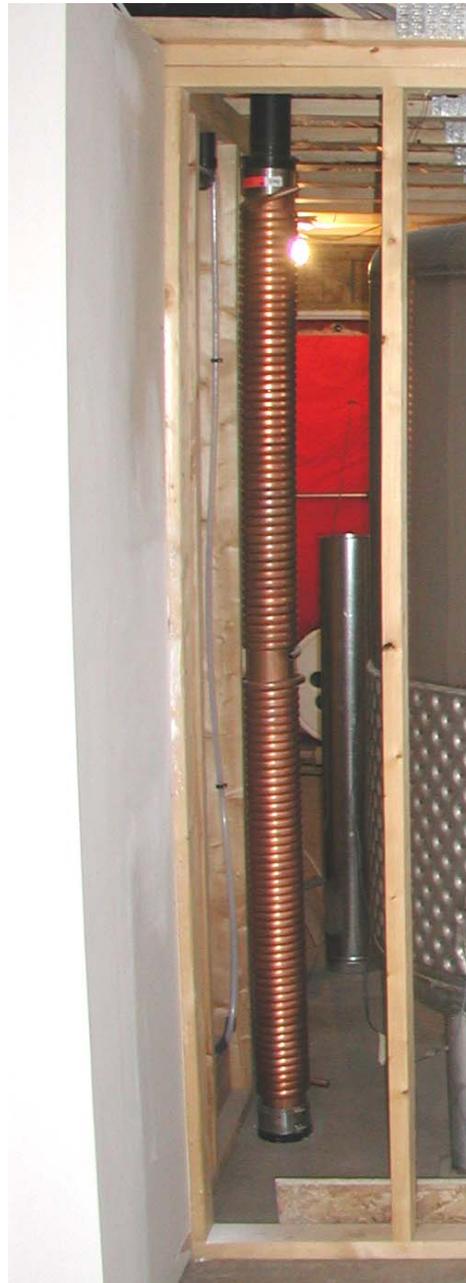
Figure 18: Copper waste water heat exchanger for the house

A drain water heat exchanger is used on the house to recover heat from the drain water from the fixtures on the on the main floor. A photo of the copper heat exchanger is shown in Figure 18. This unit recovers heat that normally would flow down the drain. If there is insufficient heat in the potable hot water after passing through the waste water heat exchanger and the solar storage tank heat exchanger, the water temperature is raised by an instantaneous electric heater.

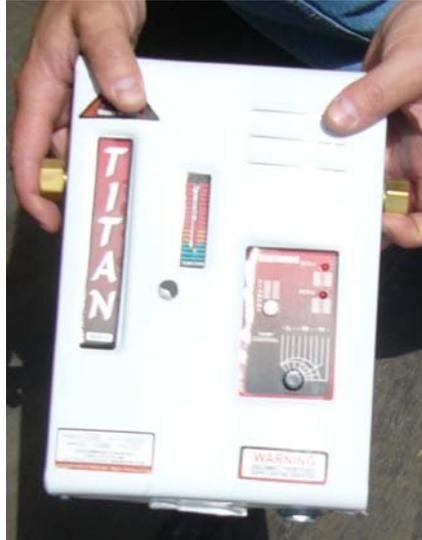
Figure 19: Instantaneous water heater

A picture of the instantaneous water heater used during the monitoring period is shown in Figure 19.

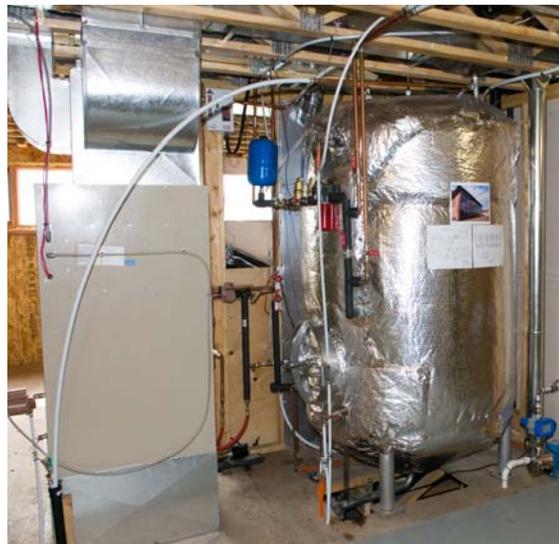
Figure 20: Fan coil

To provide space heating for the house, a fan coil incorporating a water to air heat exchanger is located adjacent to the large storage tank in the basement. A picture of the fan coil is shown in Figure 20. The fan coil is shown on the left. It takes hot water from the large storage tank and uses the hot water to provide space heating through a forced air system. The fan on the forced air system is a brushless direct current motor. The fan coil can also take cooled water from the pilings beneath the house and use this cooled water for space cooling.

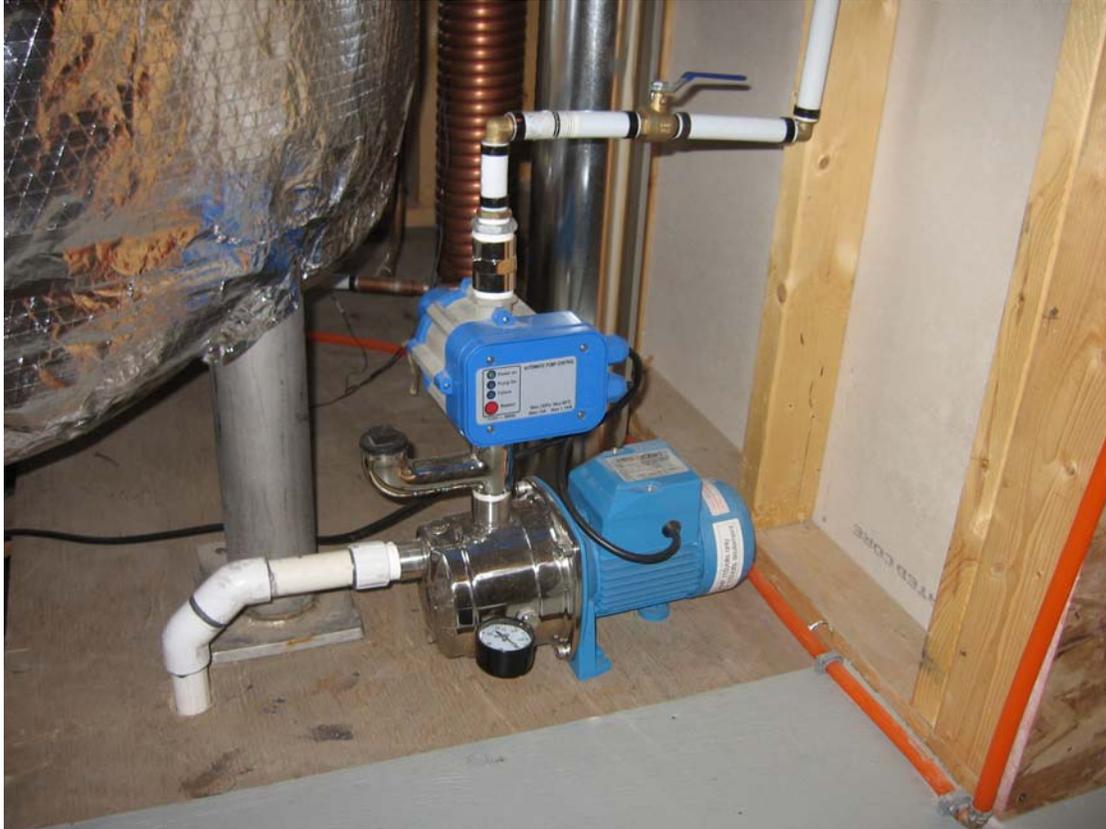
Figure 22: Water pump to supply the toilets and the exterior landscaping

A photo of the pump that is used to lift water from the cistern to the end uses is shown in Figure 22.

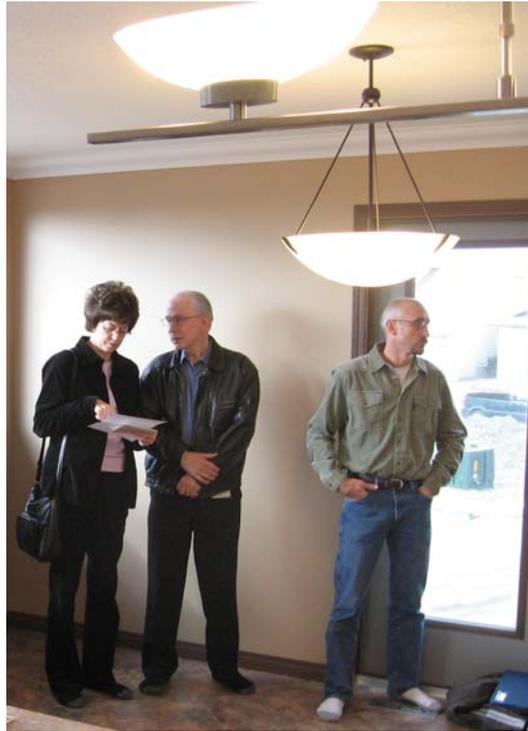
Figure 23: Light fixtures in the kitchen/dining area

Almost all of the light fixtures in the home use compact fluorescent lamps. Figure 23 shows the kitchen/dining area fixtures with compact fluorescent lamps installed.

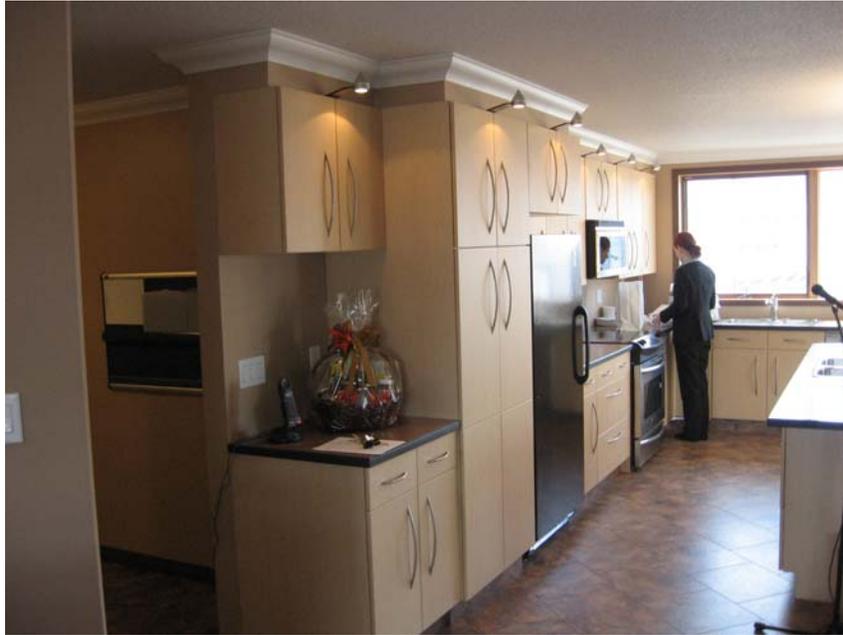
Figure 24: Halogen lamps over the kitchen cabinets

Halogen lamps were used over the kitchen cabinets (as shown in Figure 24), as compact fluorescent lamps were not available in this style. Light-sensing light emitting diode (LED) lamps were used on the risers of the staircase between the main floor and the basement.

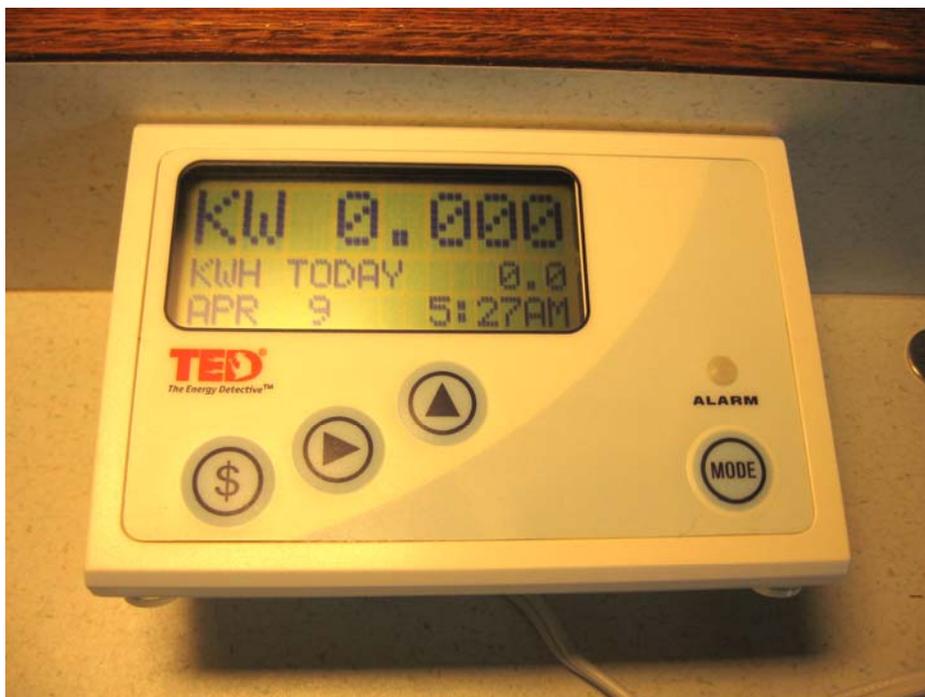
Figure 45: The Energy Detective™ instantaneous readout device

A device that gives an instantaneous readout of the electrical energy used in the house is shown in Figure 45.
