## **Former Gunnar Mining Limited Site Rehabilitation Project Proposal**

By  
Saskatchewan Research Council

SRC Publication No. 12194-3E07

April 2007

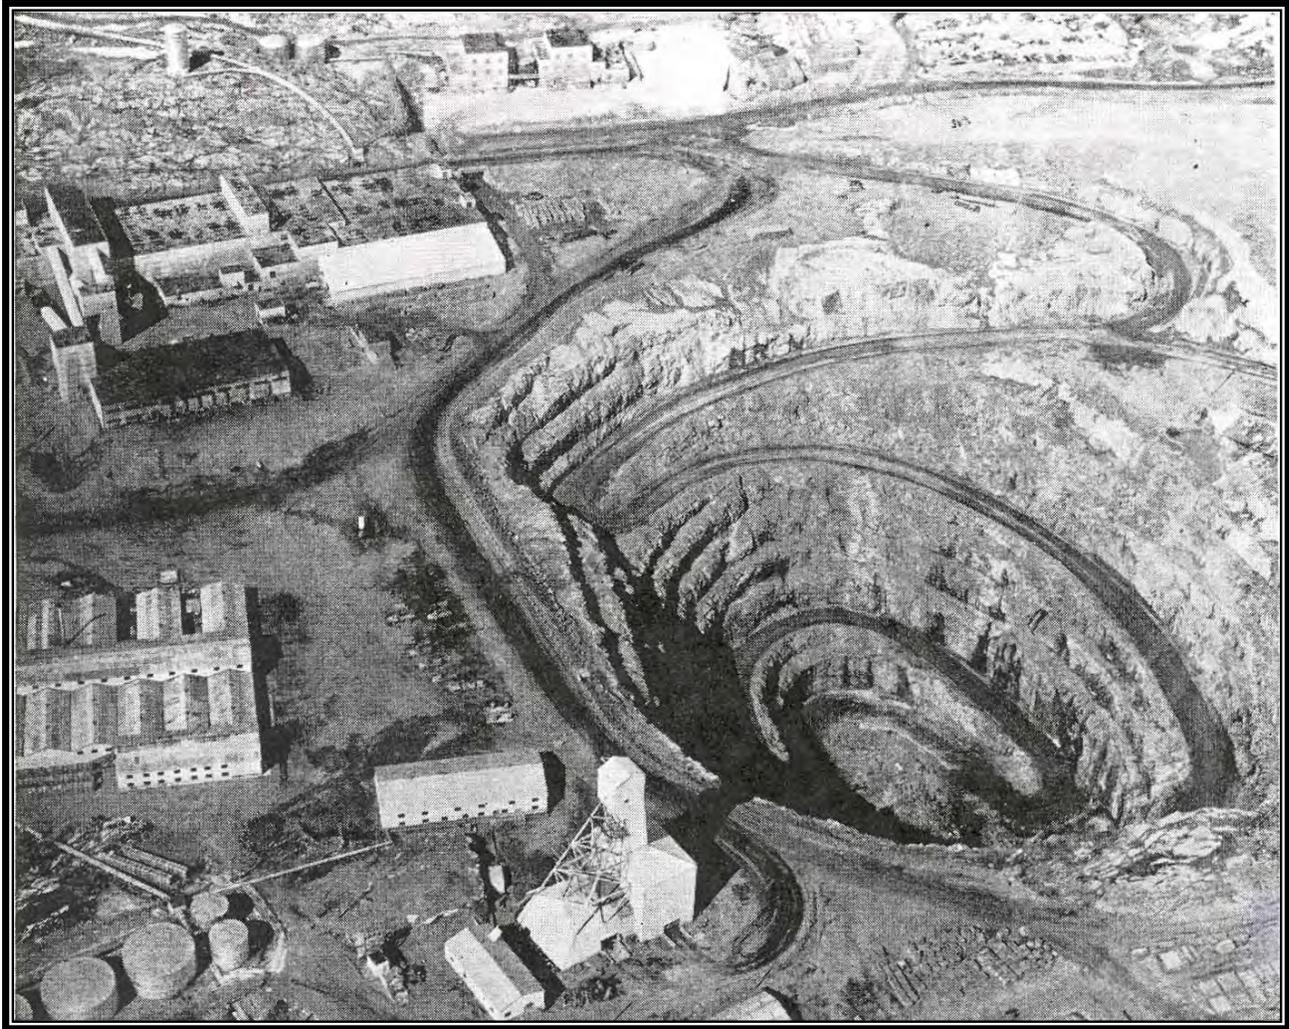
**Figure 2.1.4**  
***Gunnar Mining Ltd. Open Pit (Circa 1962)***

The open pit was 1000 feet (304 m) long, north to south, and 800 feet (244 m) wide. The final depth was 380 feet (116 m), which was 360 feet (110 m) below Lake Athabasca surface levels (see Figure 2.1.4). The upper walls of the pit were generally mined in granite gneiss.

The north wall of the pit followed closely the footwall of the ore body resulting in the bulk of waste rock being produced from a large crescent-shaped mass in the south end of the pit decreasing in size with depth. The rock was mined in 30-foot vertical benches with a 21-foot berm on each bench. As a result, the wall angle was approximately  $55^{\circ}$  except where modified by haulage roads.

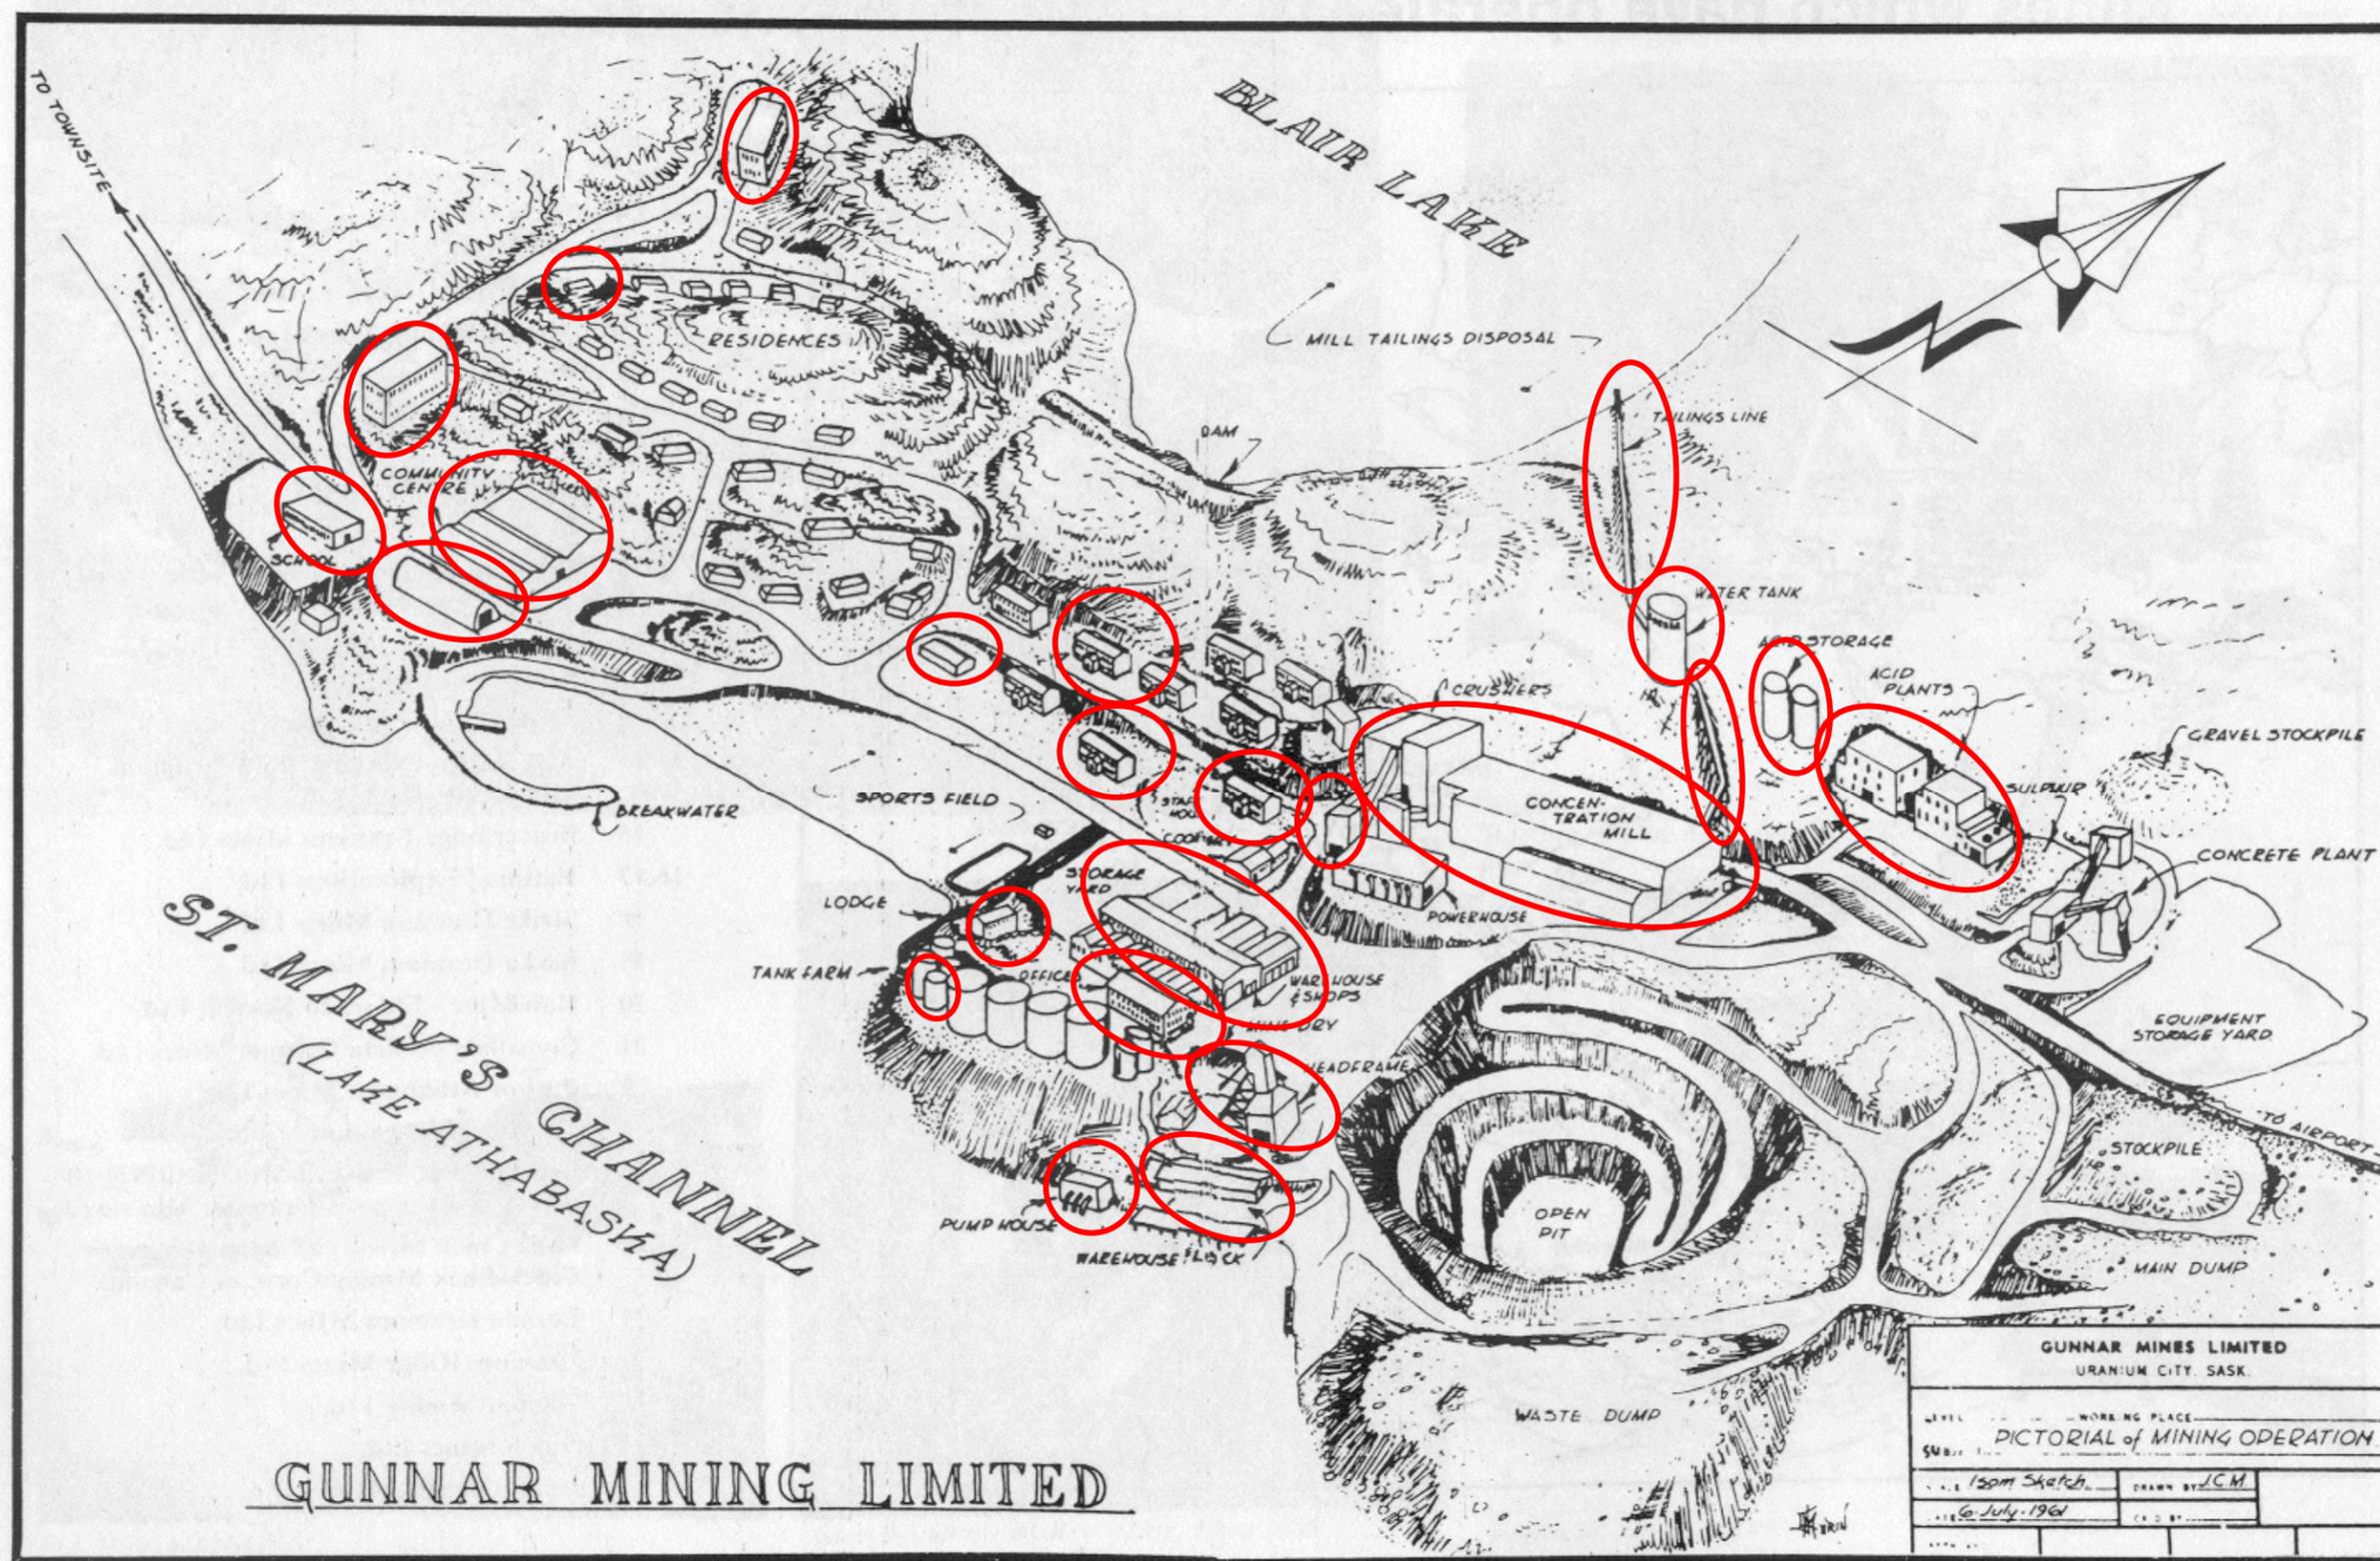
**Figure 8.1.1**  
Existing Facilities

#	Description
1	Headframe
2	Mill
3	Acid Plant
4	Pumphouse
5	Geology/Mine Dry
6	Office/Engineering
6B	Maintenance Shop
7	Warehouse
8	Apartment Housing
9	Apartment Housing
10	Cold Storage
11	Community Centre
12	Curling Rink
13	School
14	Sewage Treatment
15	Married Apartments
16	Married Apartments
17	Pump Shed
18	Concrete Basement
19	Apartment Housing
20	Apartment Housing
21	Cabins
22	Cabins
23	Barge
24	Lodge
25	Tailings Pipeline
26	Acid Storage Tanks
27	Water Tank

The head frame covers an area 120 ft. by 76 ft. and is on a reinforced-concrete foundation wall pinned to bedrock. It has a total height of 157 ft. and is sheeted with asbestos siding. The entire interior was insulated with spray on asbestos fibre.

A 76 ft. by 48 ft bin house is incorporated in the head frame and contains two 1,000-ton storage bins. There is no residual ore in either of the bins and very little scrap material scattered on the floor in this area. No chemicals were found.

Within the acid plant buildings, there is an accumulation of more than 90 barrels that were used to store the spent vanadium pentoxide pellets used as a catalyst in the process. Many of the barrels have corroded over time and the pellets have spilled onto the floor.

There are two 40 ft. diameter by 30 ft. high insulated acid storage tanks located behind and slightly to the west of the acid plant on an adjacent elevated rock outcropping. The tanks are empty and most of the conduit piping has rusted away.

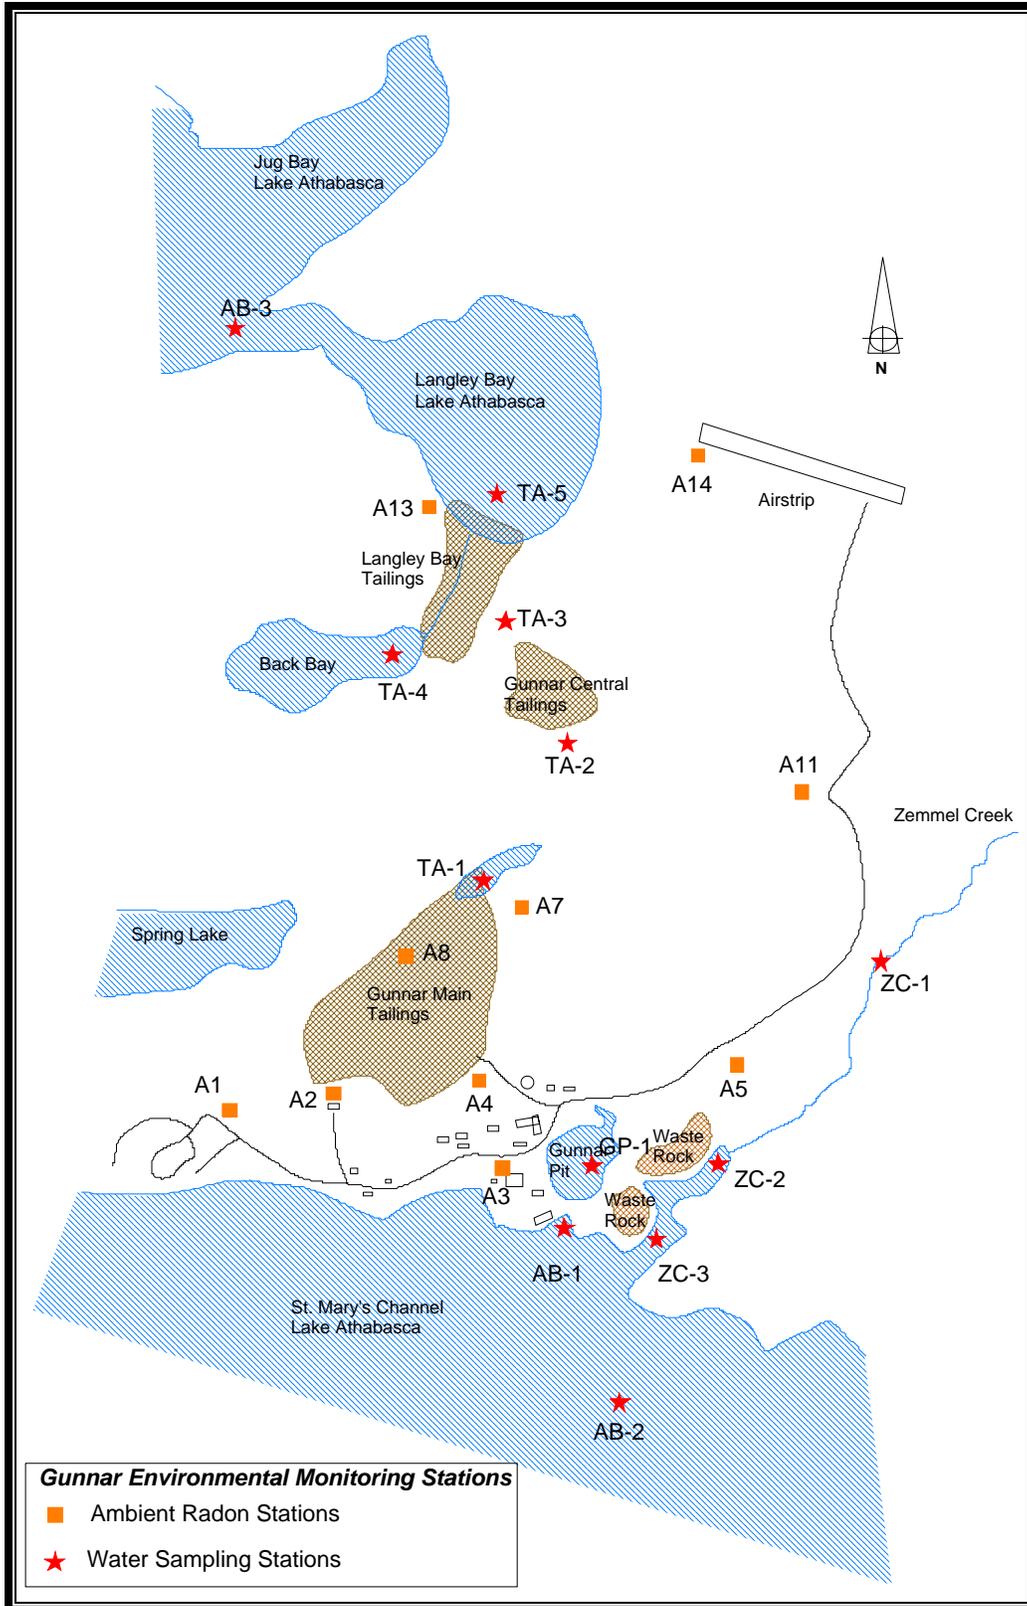
Figure 14.1.1 provides a summary of water quality stations from which water samples will be collected in order to enhance the data base of the former Gunnar Mining Ltd. site.

<b>Station</b>	<b>Location</b>	<b>Frequency</b>	<b>Parameters</b>
AB-1	St. Mary's channel oposite pit discharge	June, September, December	General chemistry package, ICP-MS metals plus bismuth, mercury, phosphorous, ammonia (NH <sub>3</sub> ), nitrate + nitrite, total kjeldahl nitrogen, total nitrogen, organic carbon, total suspended solids, lead-210, and radium-226
AB-2	St. Mary's channel central channel		
AB-3	Langley Bay Discharge		
GP-1	Gunnar flooded pit		
ZC-1	Zeemel Creek upstream of site		
ZC-2	Zeemel Bay at Zeemel Creek discharge		
ZC-3	Zeemel Bay outlet to St. Mary's channel		
TA-1	Gunnar main poded water		
TA-2	Tailings Creek		
TA-3	Between Gunnar central and Langley		
TA-4	Back Bay		
TA-5	Langley Bay
