CNSC COMMISSION MEMBER DOCUMENT (CMD)

CMD 16-H6.1

WNSL Phase II hold point release to proceed with the Gunnar Remediation Project
"Other Site Aspects"

Saskatchewan Research Council

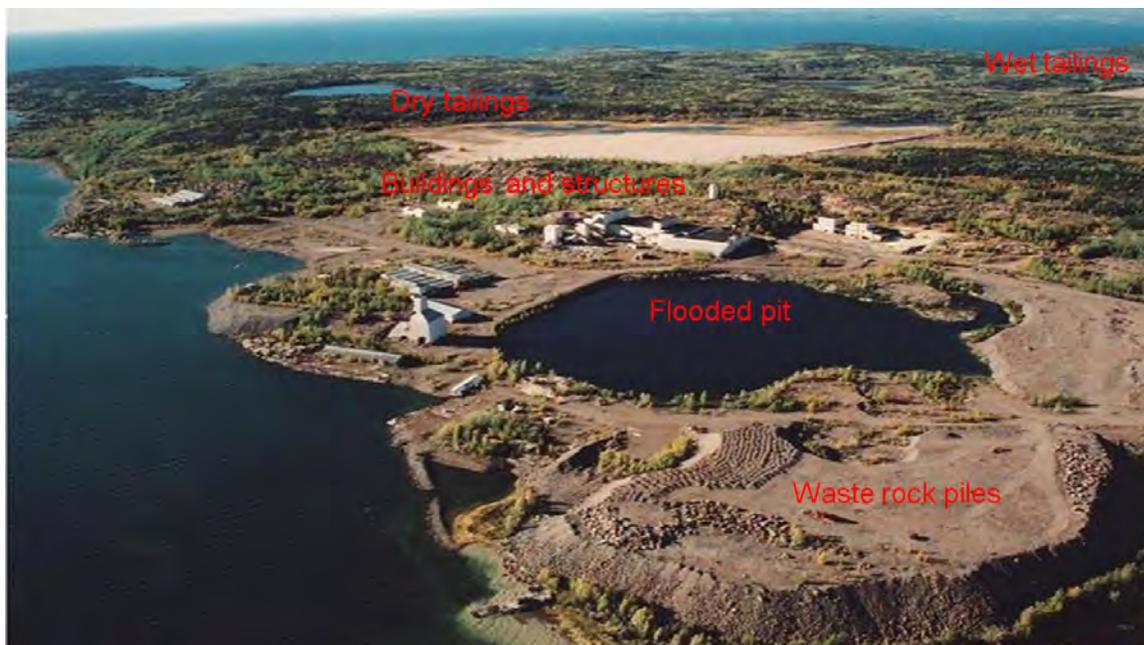
Figure 2. Gunnar mine site before demolition of buildings and structures (2009)

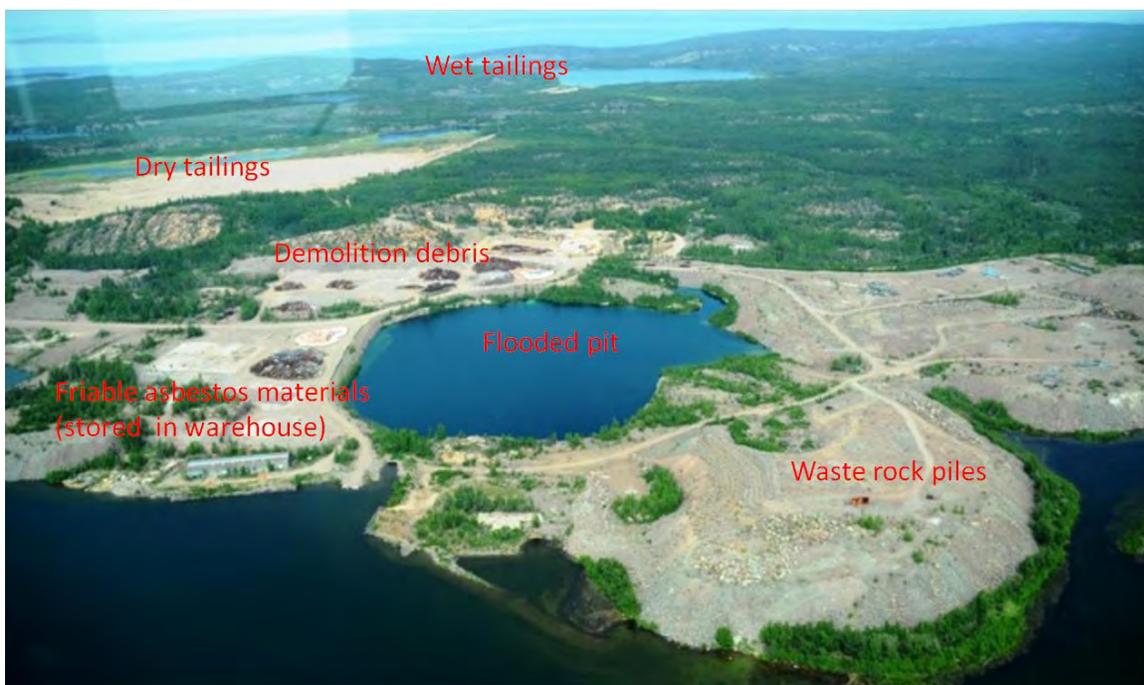
Figure 3. Gunnar mine site after the demolition activities (2013)

All these materials are subject to proper disposal on the Site pending selection of preferred remediation options and waste disposal methodology (see Section 3.1).

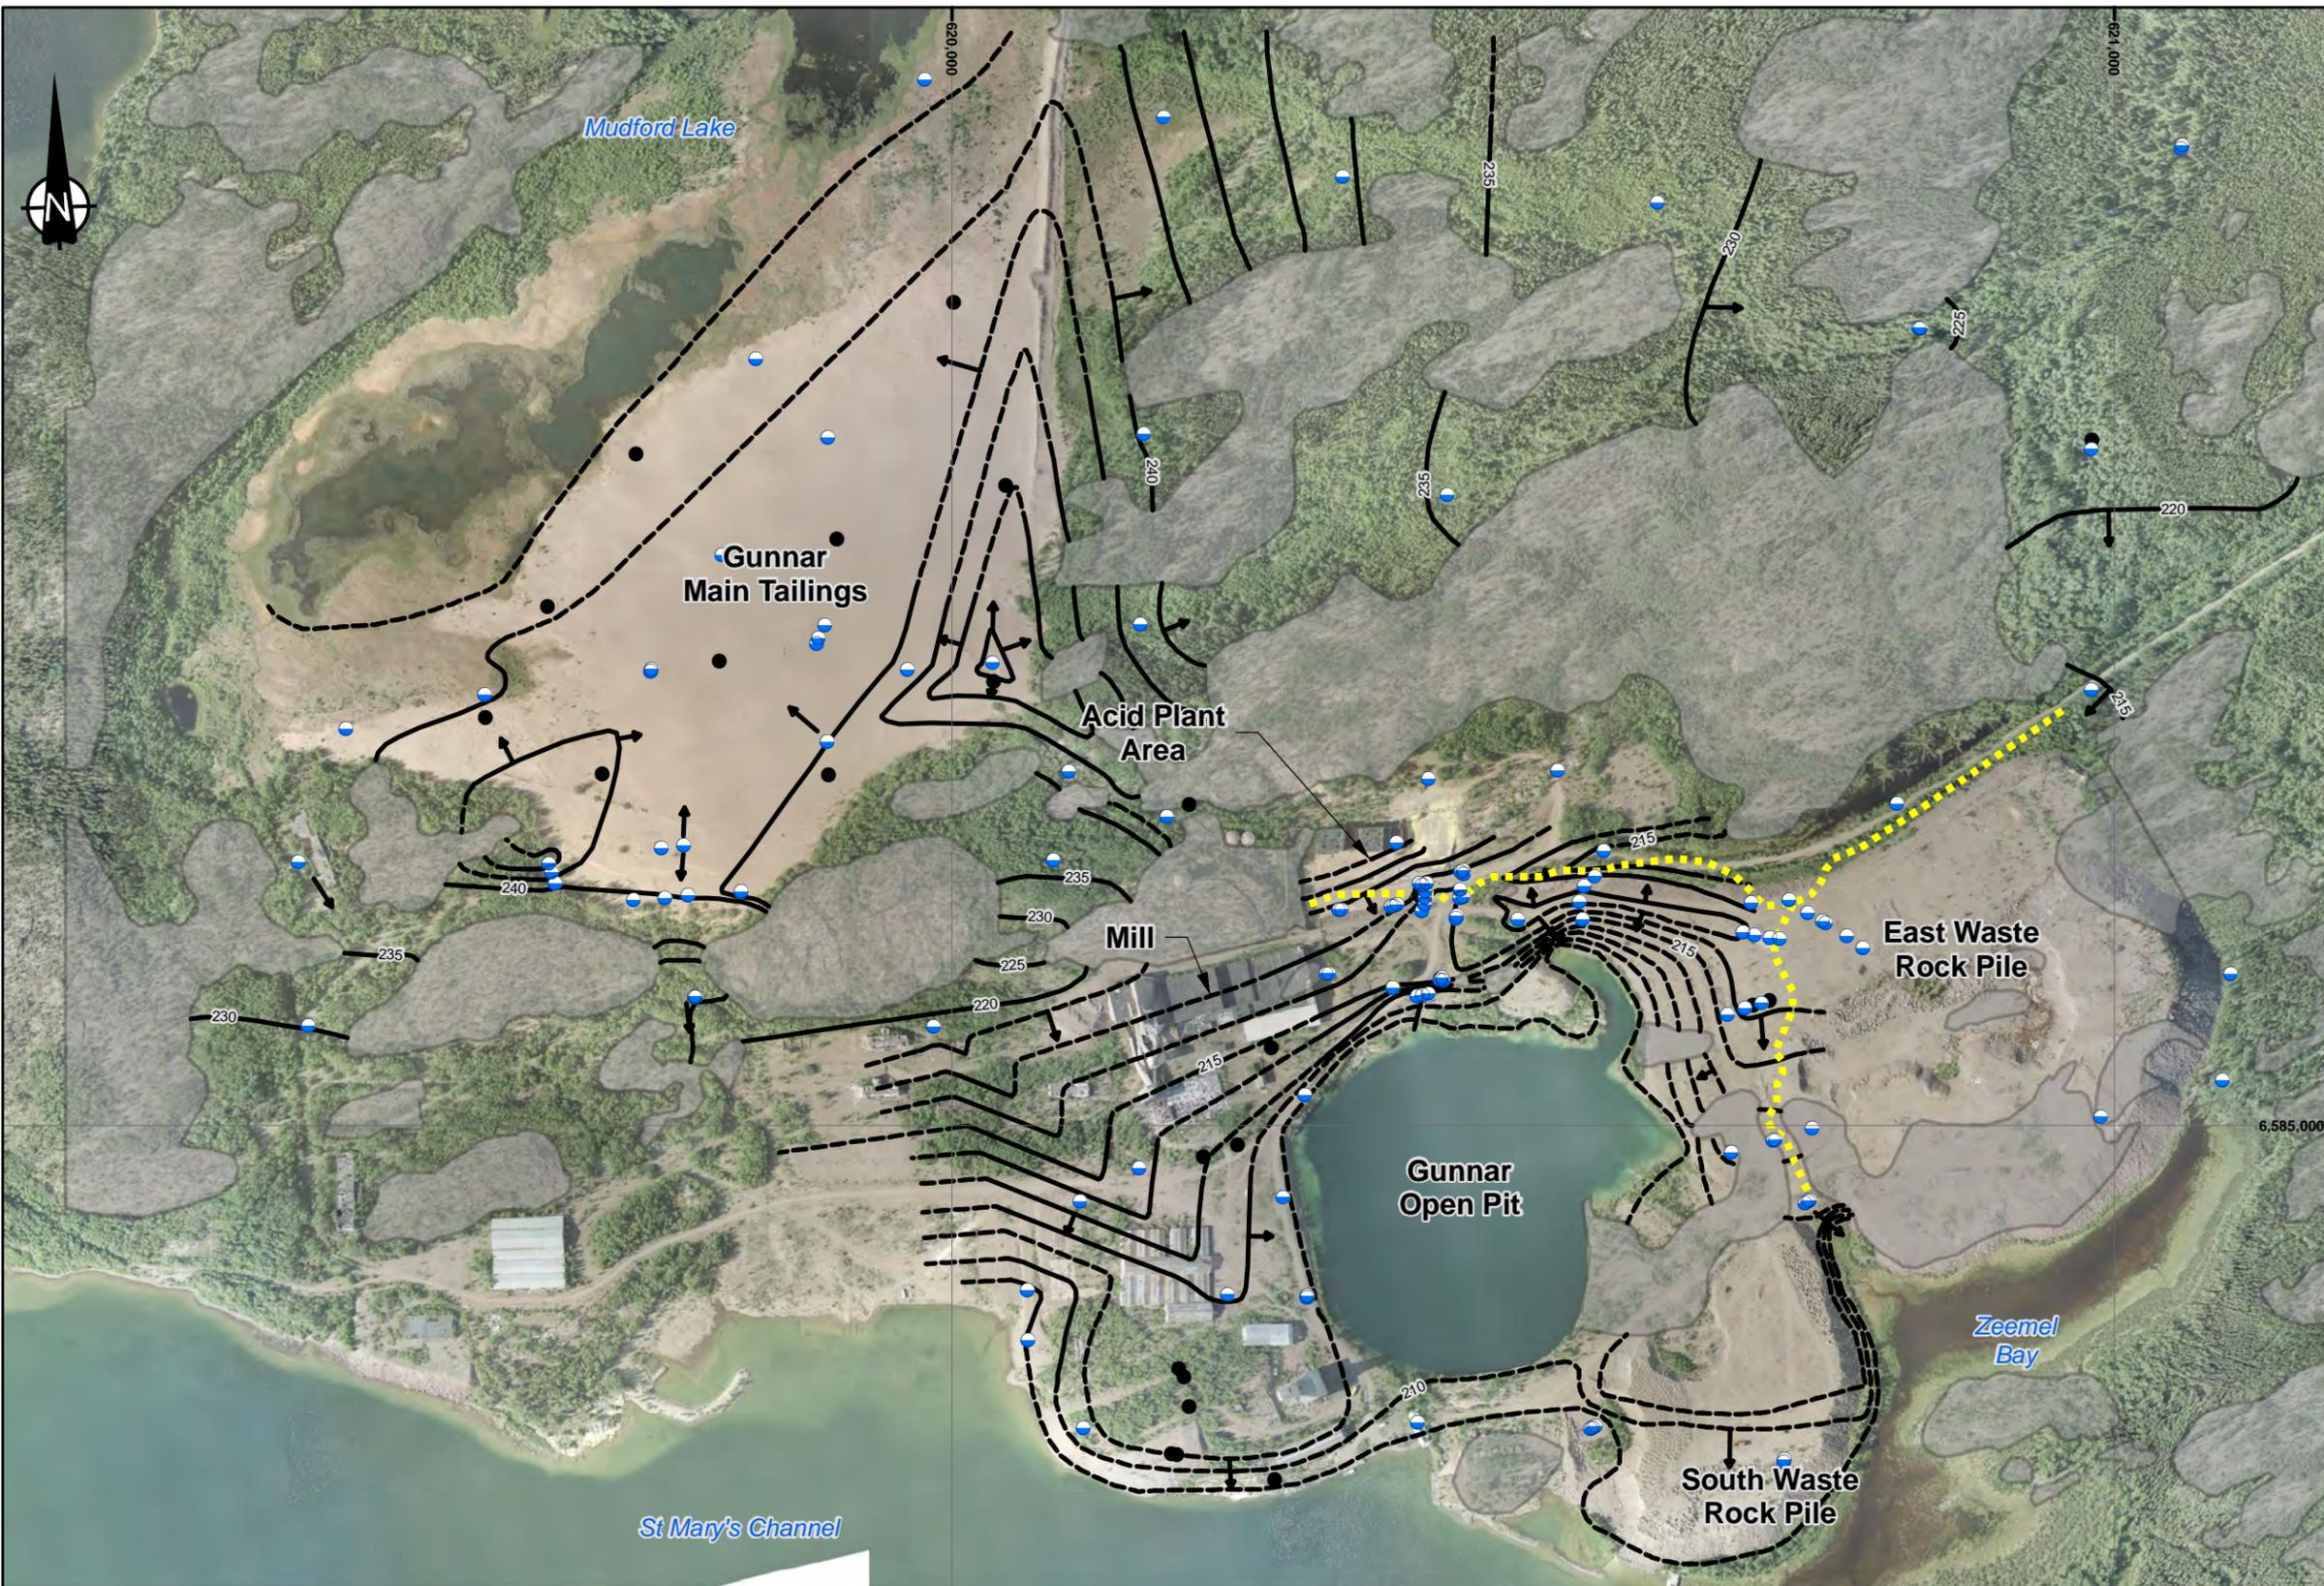
Date: JULY 2016	Approved: TPP / EMR	Figure: 5
--------------------	------------------------	---------------------

- Borehole
- Piezometer
- Water Elevation
- - - Inferred Water Elevation
- Inferred Buried Channel

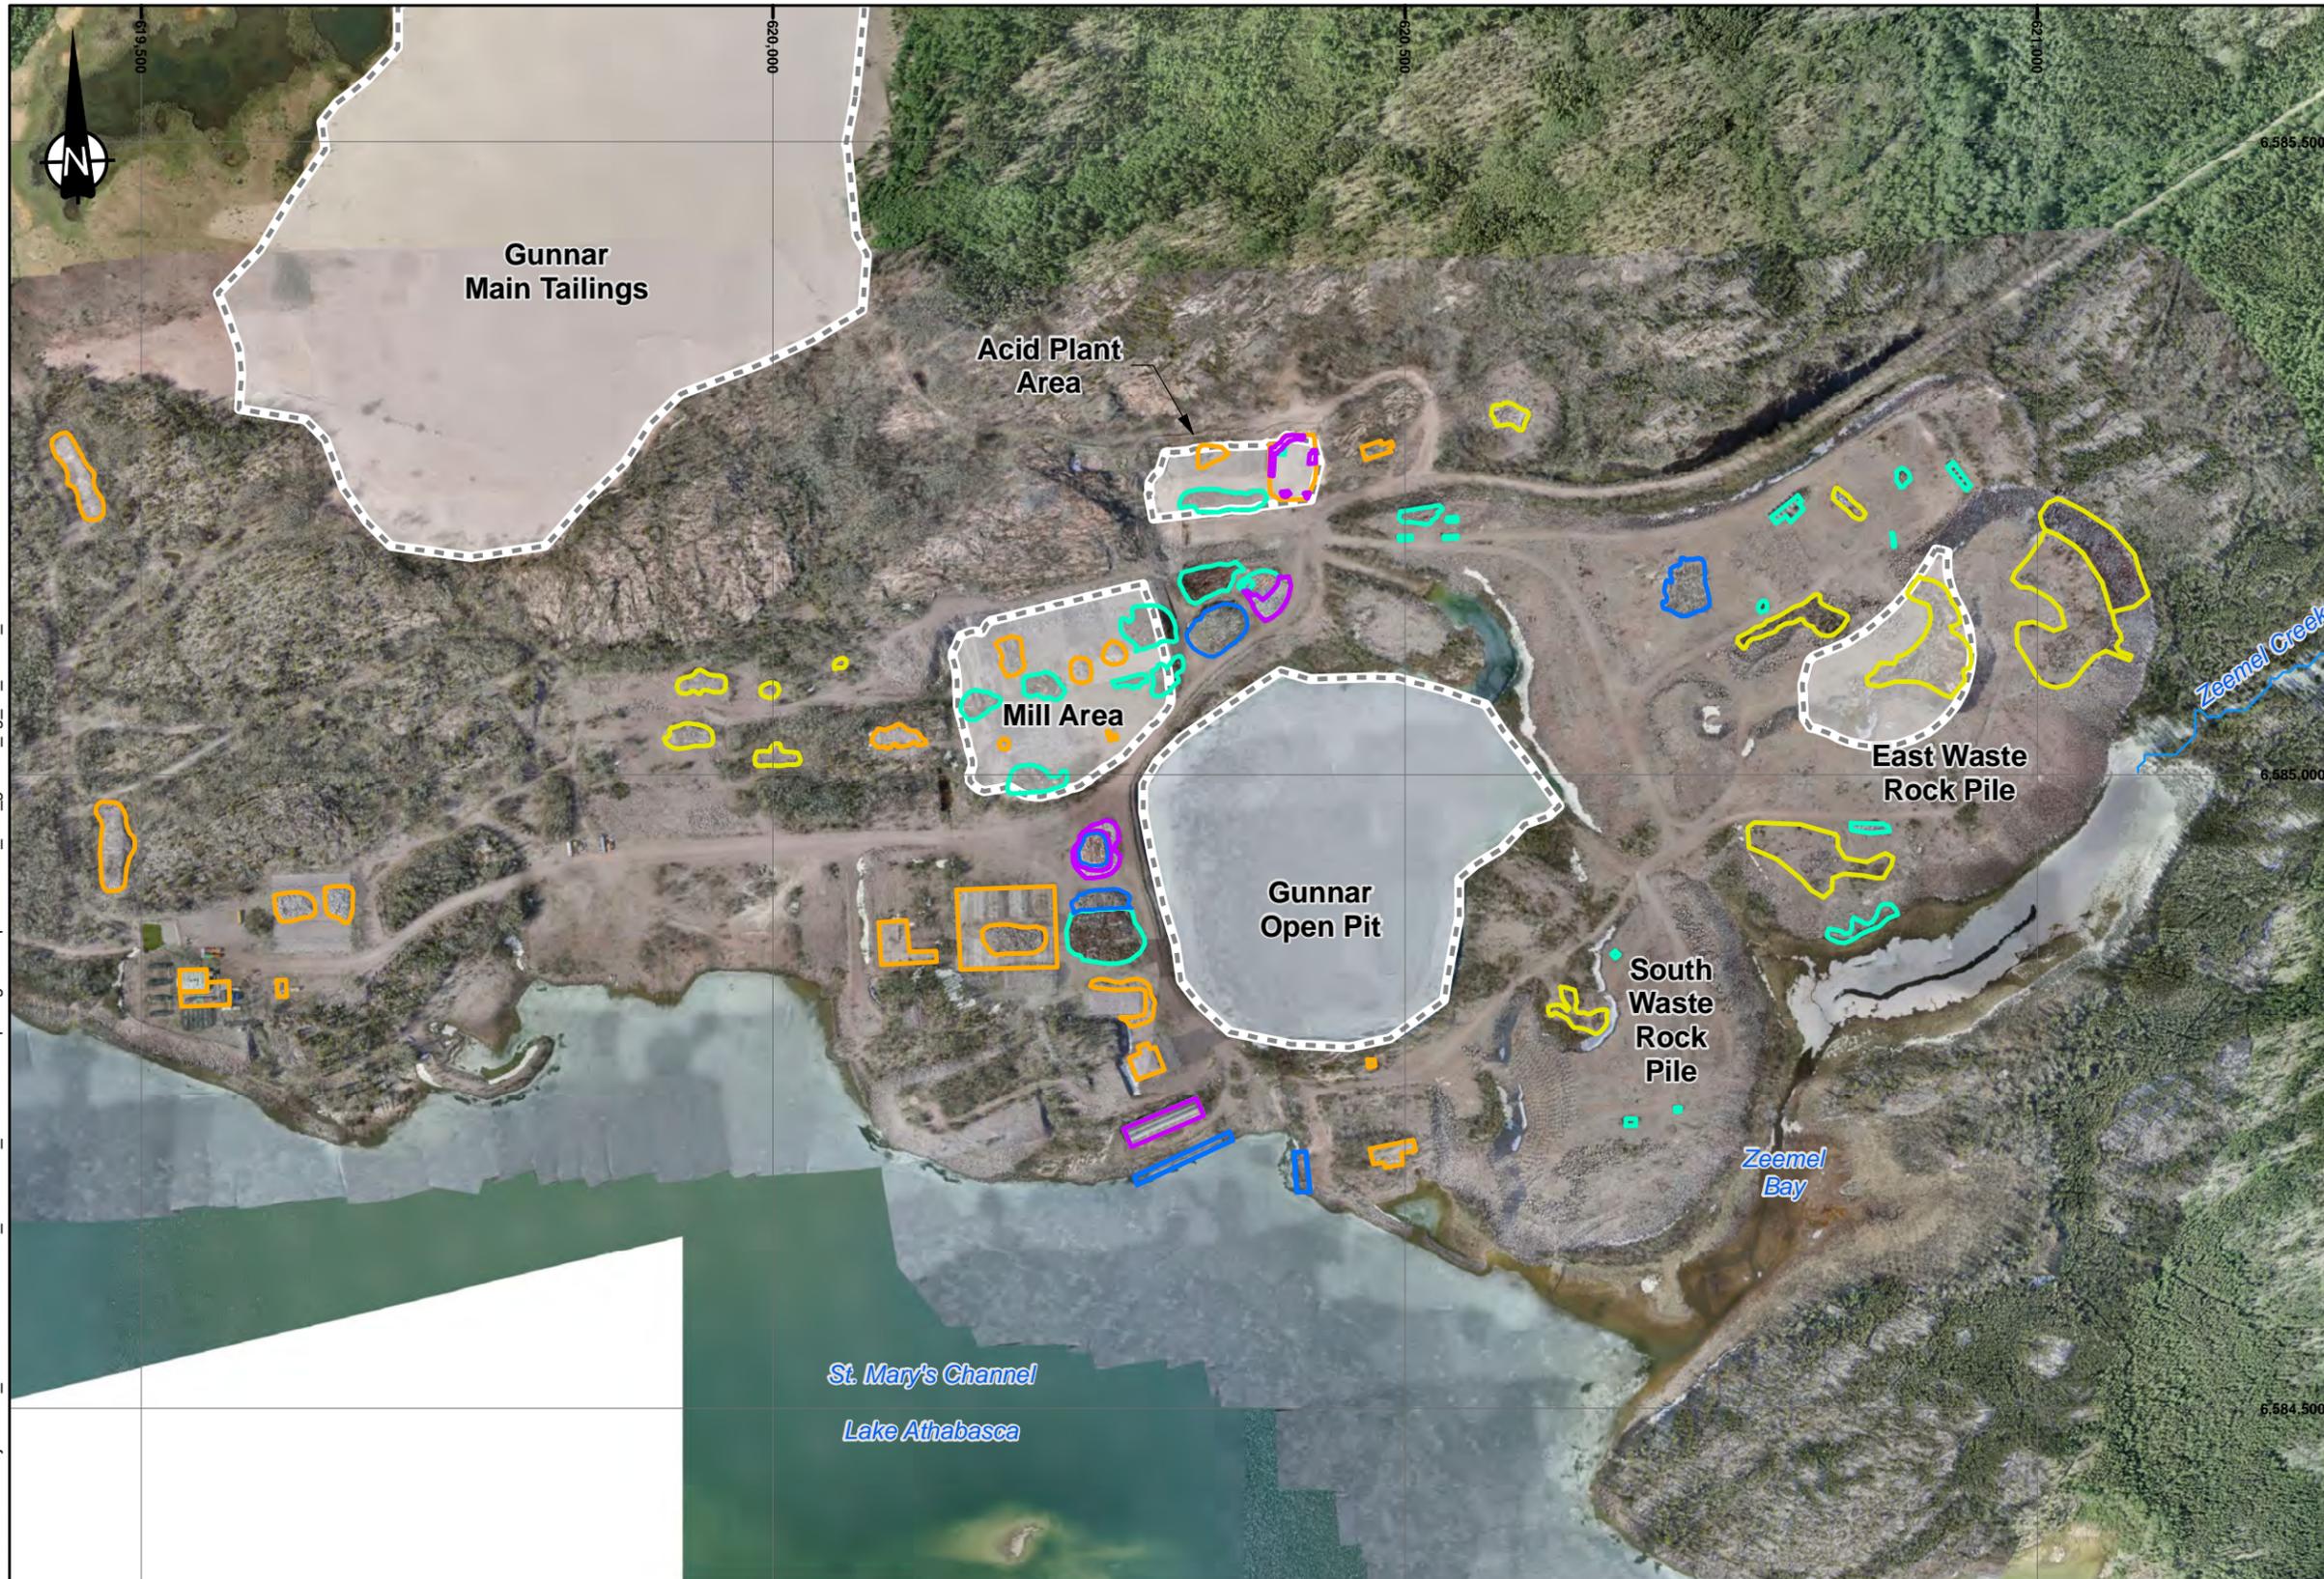
- Debris Storage Option Area
- Debris Classification**
- ACM (Bags)
- CONCRETE
- MIXED (See Notes)
- STEEL
- Wood Debris

Non-Hazardous Demolition Debris:

- Consolidate the non-hazardous demolition debris into one landfill located at the Mill Complex area.
- Place all asbestos containing material (ACM) at the base of the landfill followed by the steel, concrete, and shredded wood demolition debris.

- Wood debris will be chipped/mulched and if possible, will initially be utilized for erosion control to support the waste rock pile cover systems. For volumetric assessment purposes (i.e. to ensure landfill capacity is conservatively high), the preliminary design of the non-hazardous landfill incorporates approximately half of the total wood debris volume. The chipped/mulched wood debris will be placed in thin layers over the steel demolition debris with the intent to fill in voids.

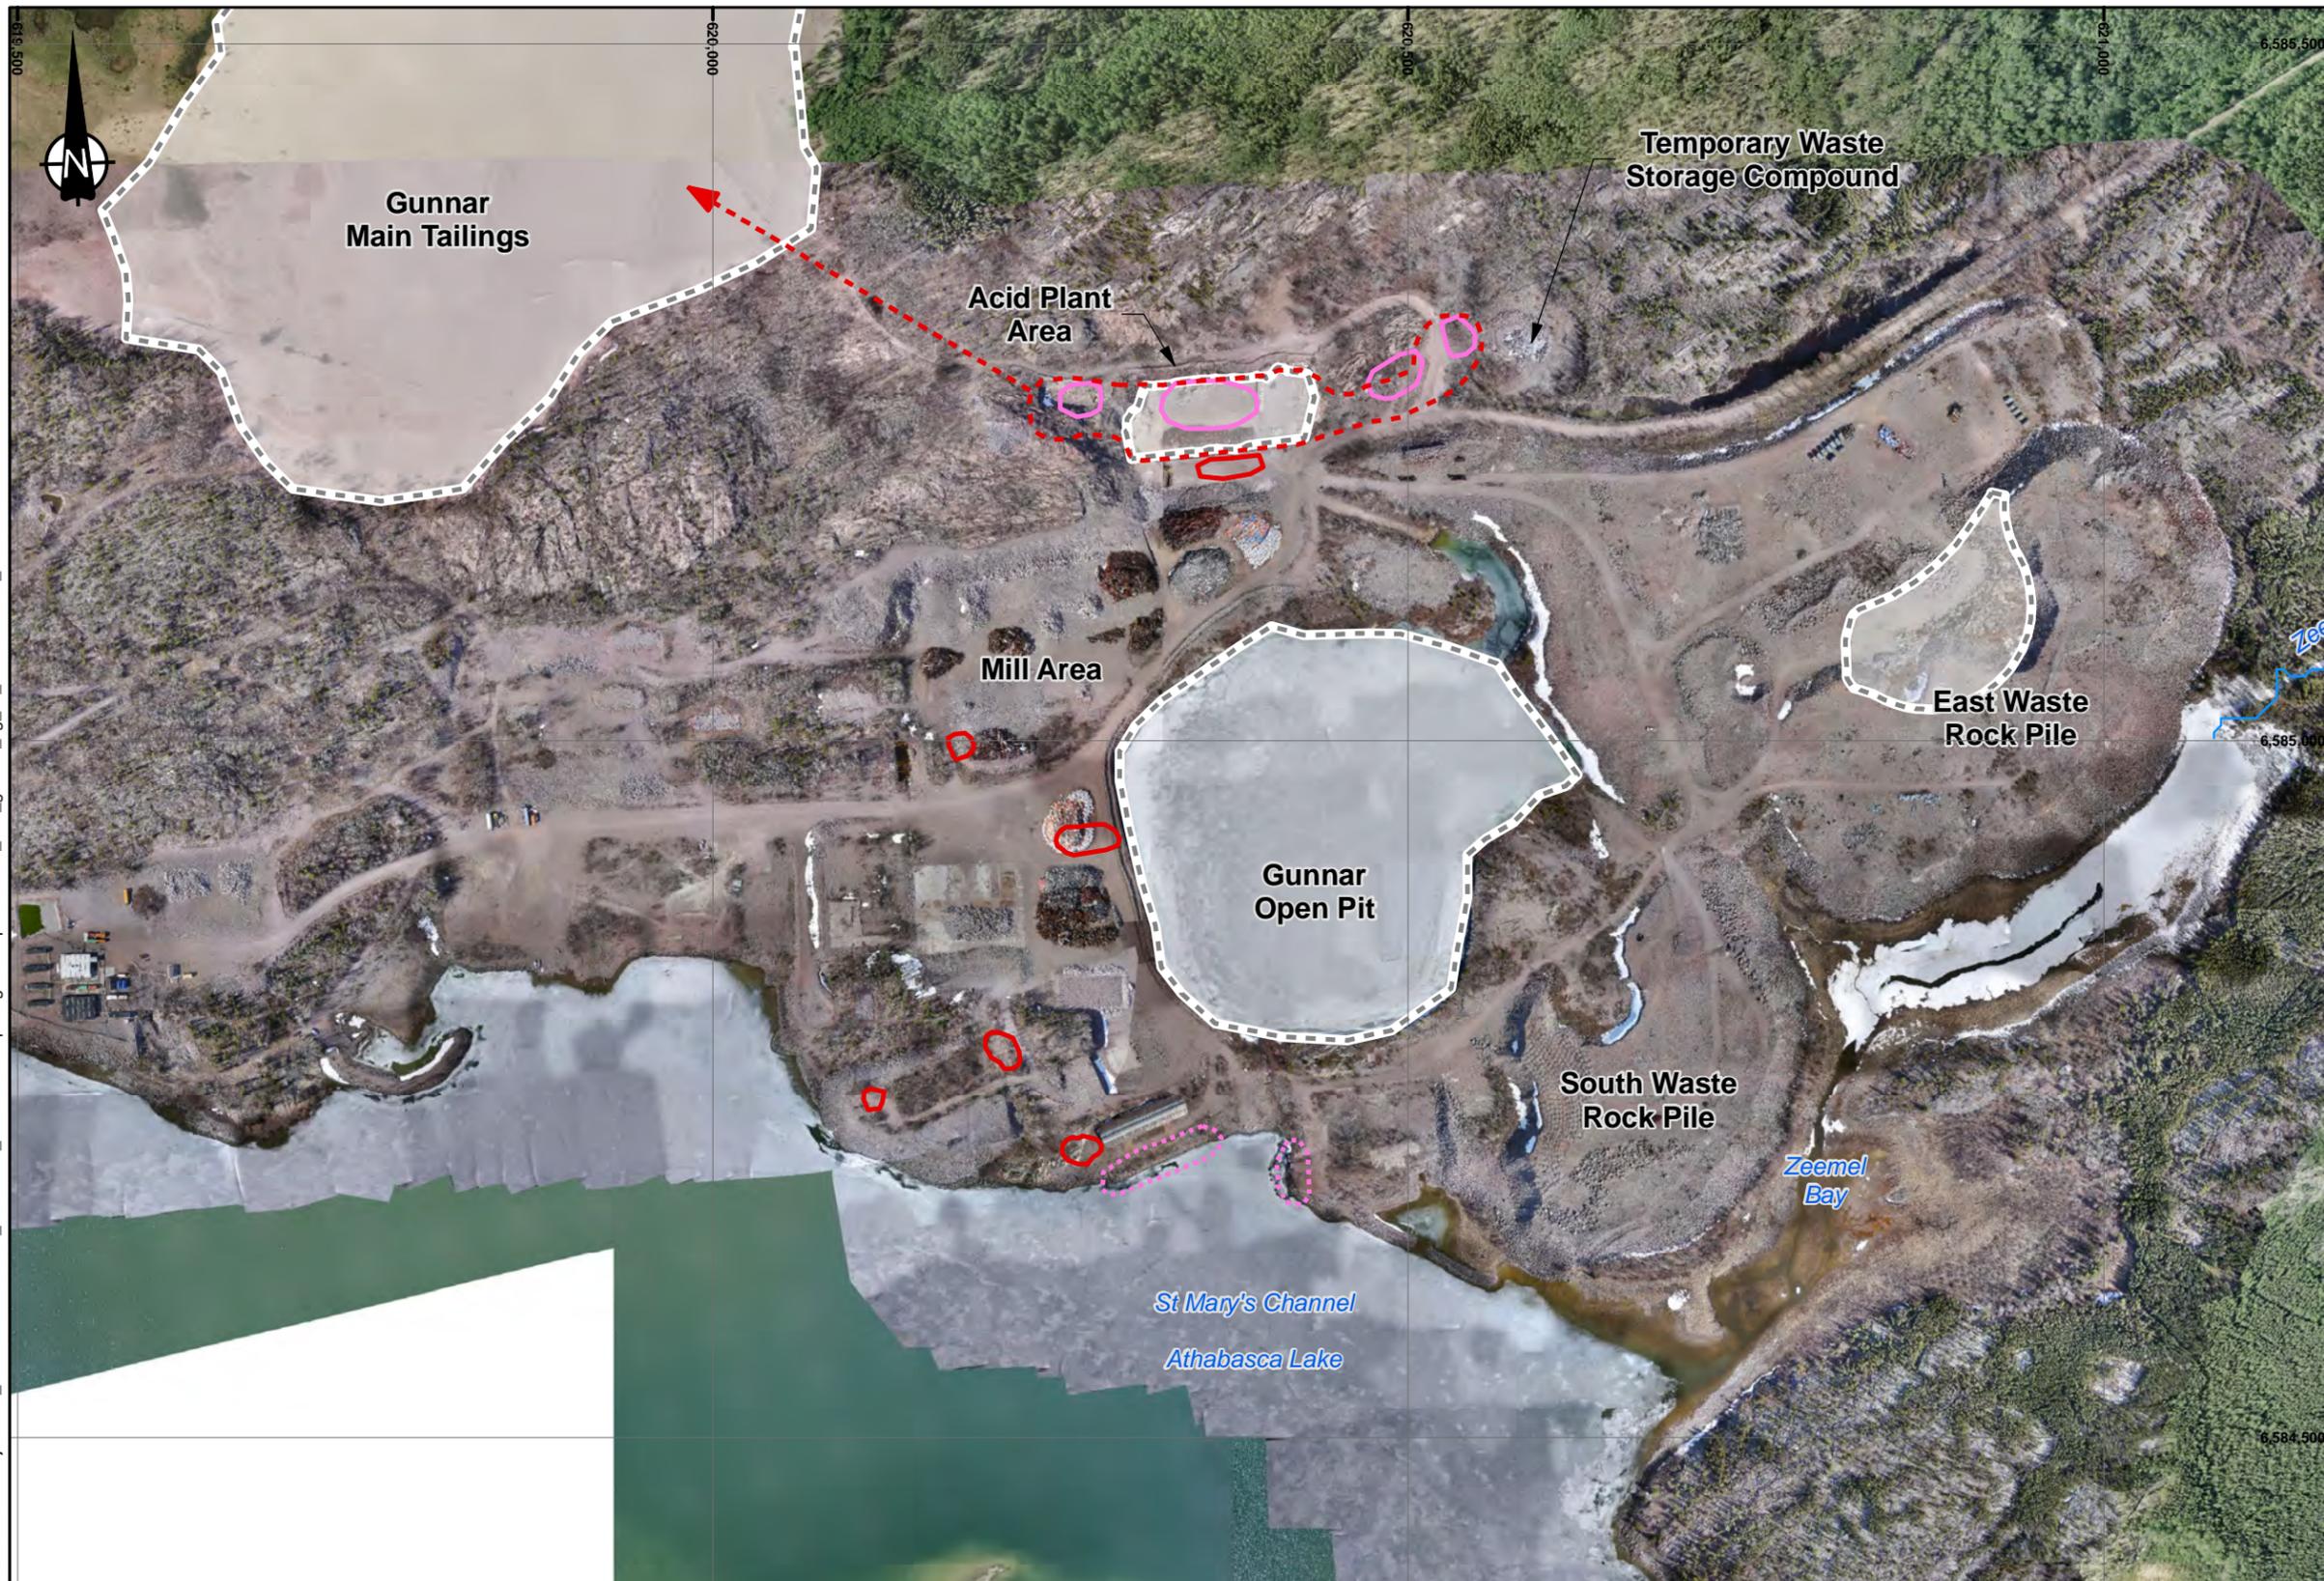
- Contaminated Soil Storage Option
- Contaminated Soil
- Acid Plant Excavation to Gunnar Main Tailings
- Area of Low pH / Acid Generating Material
- Potentially Sulfur or Sulfide Containing Material

- Excavate and remove pH impacted waste rock and soil from the Acid Plant footprint and dispose in Gunnar Main Tailings (GMT).
- Prepare the bedrock foundation so that it meets the hydraulic conductivity requirement stipulated in the Saskatchewan Environmental Code for landfills.

- Consolidate the contaminated soil/waste rock demolition debris into one landfill located at the Acid Plant area.
- Construct a minimum 1.0 m thick low permeability cover that will tie-in to the Acid Plant prepared bedrock surface and/or concrete pad. Construct a 3.3 m thick frost protection layer comprised of non-hazardous waste (concrete and/or waste rock). This layer will be followed with the placement of 0.5 m thick vegetated cover consisting of coarse textured borrow material. This layer will direct surface water flow towards St. Mary's Channel.

- Excavate and remove pH impacted waste rock and soil from the Acid Plant footprint and dispose in GMT.
- Prepare the bedrock foundation so that it meets the hydraulic conductivity requirement stipulated in the Saskatchewan Environmental Code for landfills.

- Consolidate the contaminated soil/waste rock demolition debris into one landfill located at the Acid Plant area.
- Construct a minimum 1.0 m thick low permeability cover (compacted clay cover) that will tie-in to the Acid Plant prepared bedrock surface and/or concrete pad. Construct a 3.3 m thick frost protection layer comprised of non-hazardous waste (concrete and/or waste rock). This layer will be accommodated by the non-hazardous landfill as it abuts against the slope of the compacted clay layer. The exterior of the landfill will include a 0.5 m thick vegetated cover consisting of coarse textured borrow material. This layer will direct surface water flow towards St. Mary's Channel.

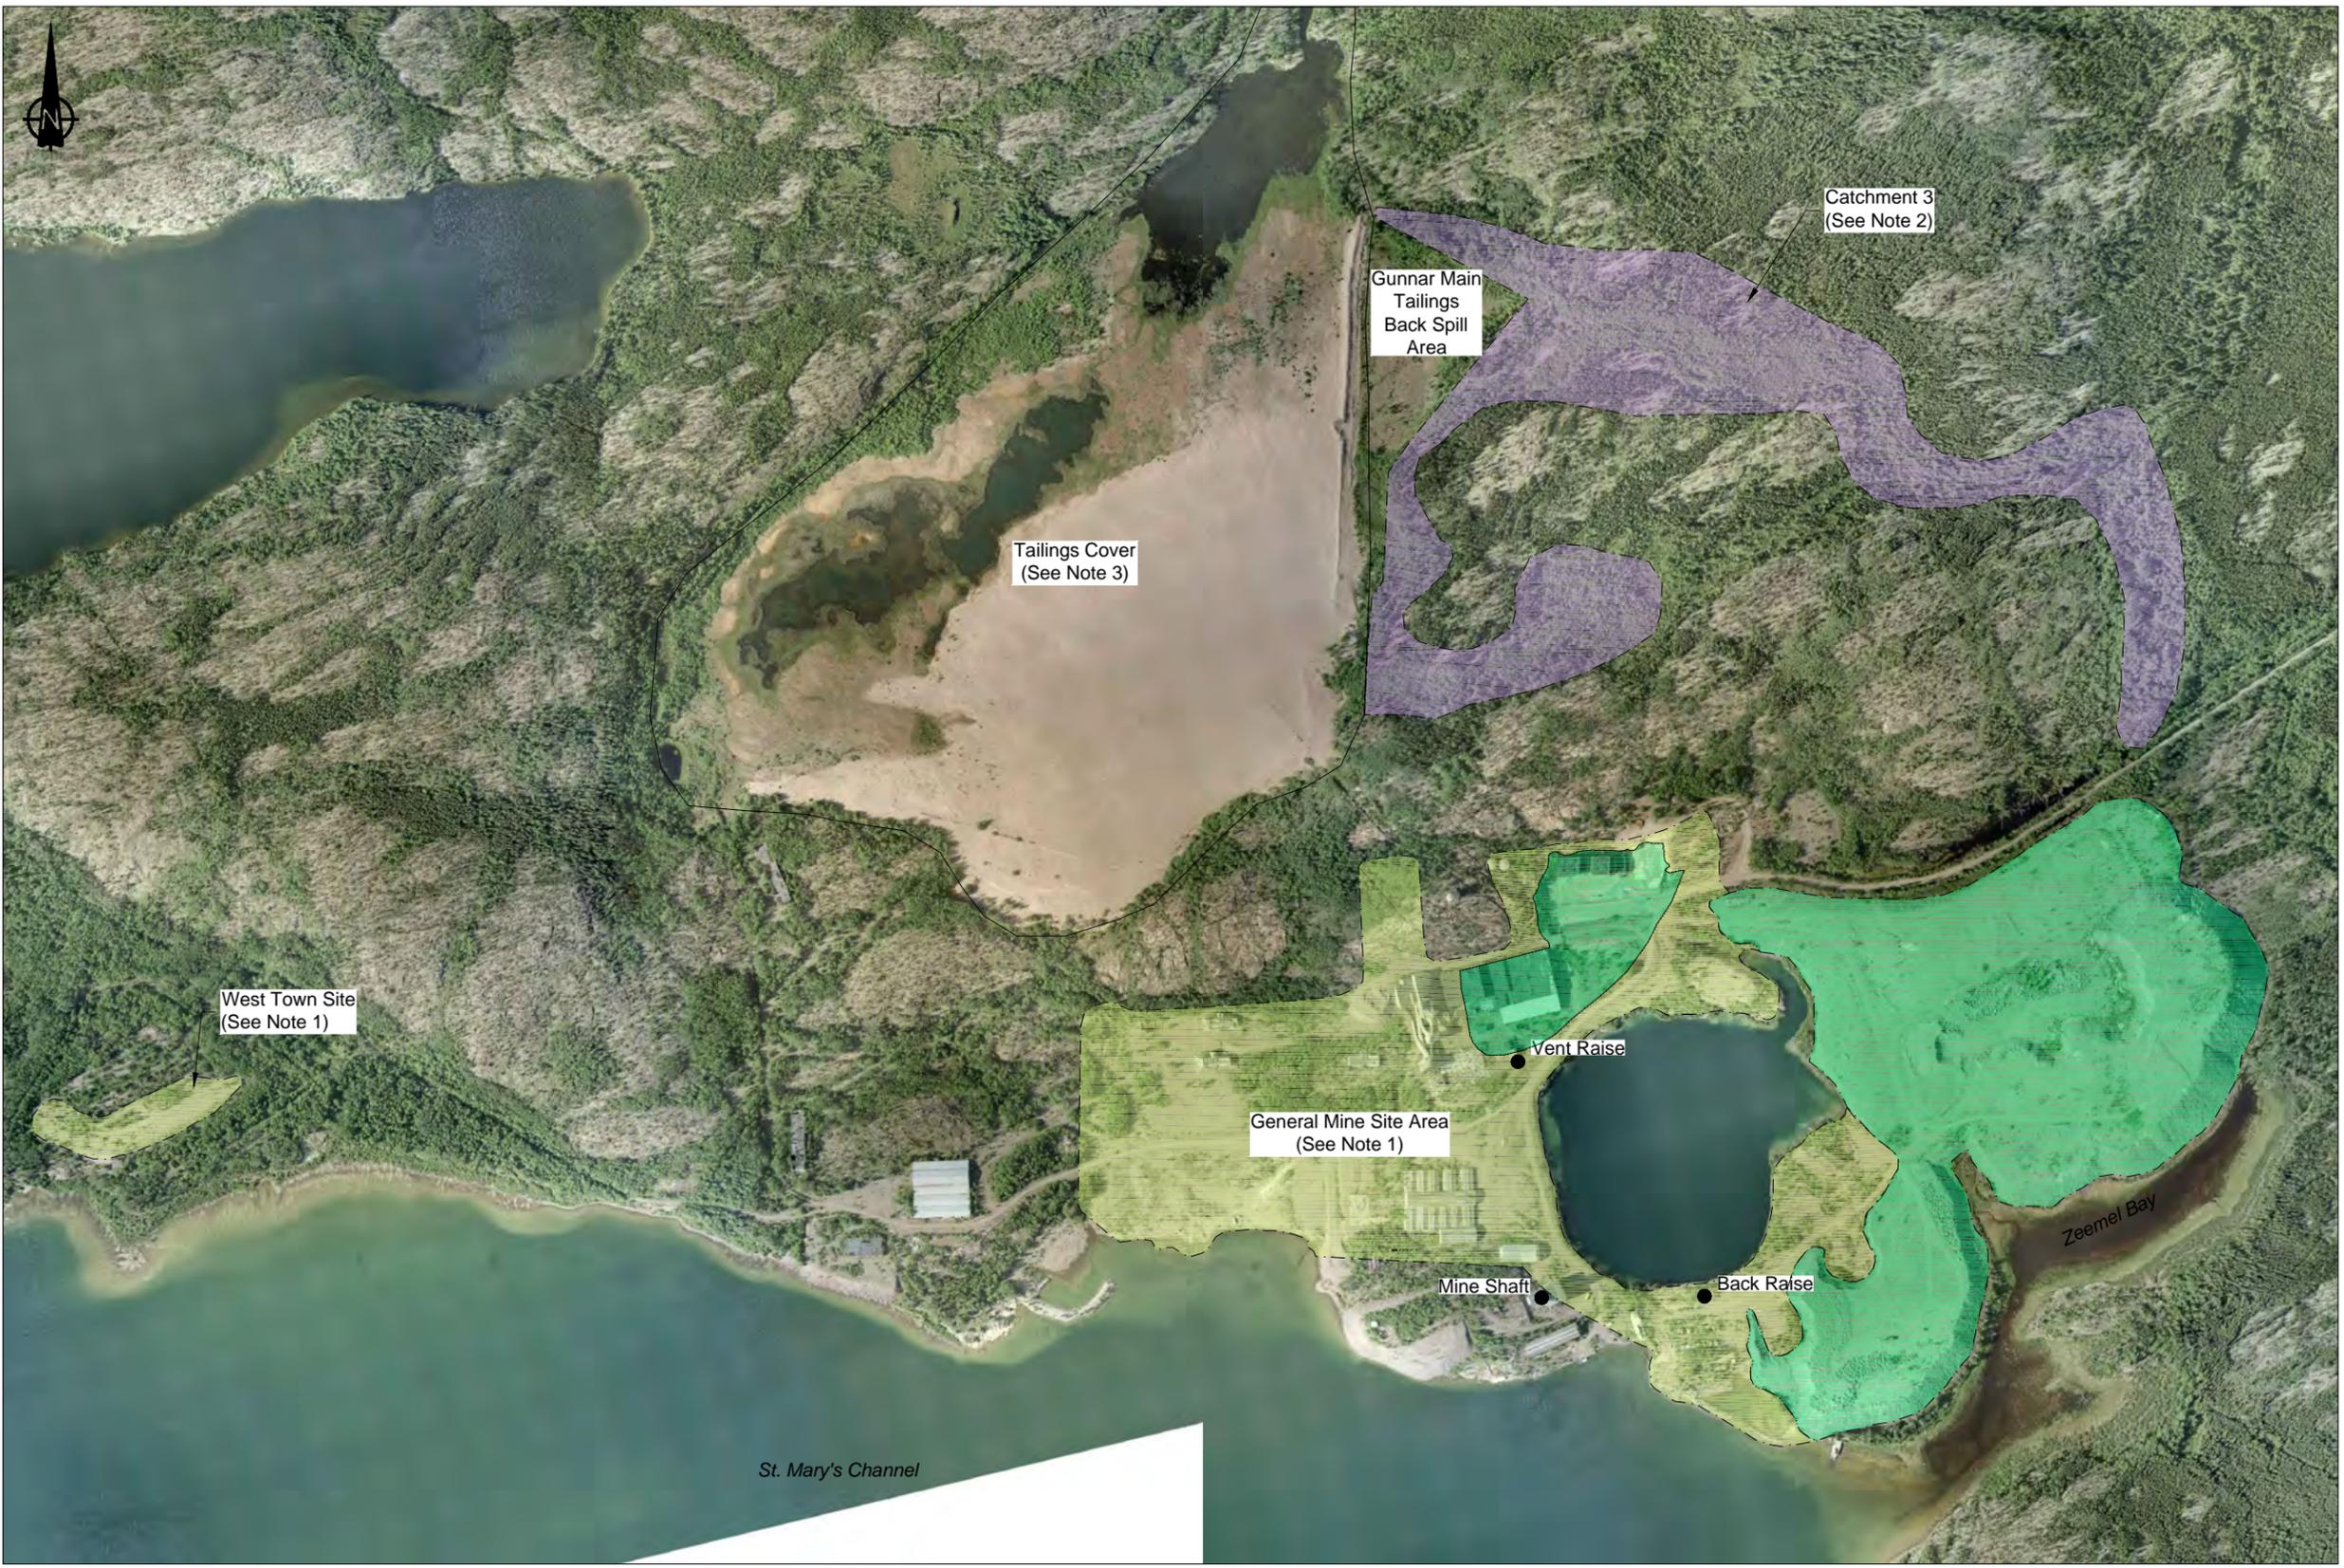
UPDATED PRELIMINARY REMEDIATION DESIGN		
		TYPICAL CULVERT DETAIL		
SRK JOB NO.: 1CS056.003 FILE NAME: 1CS056.003 - Plan and Sections.dwg	GUNNAR MINE "OTHER SITE ASPECTS"	DATE: JULY 2016	APPROVED: TPP/MWL	FIGURE: 25

- GAMMA SURVEY ($\mu\text{Sv/h}$)**
- Engineered Cap over Mine Opening
 - Area with elevated gamma above $1.4 \mu\text{Sv/h}$ per ha.
 - Area requiring 0.5m thick borrow cover
 - Cover completed via other remedial designs

- NOTES**
1. The Town Site and General Mine Site area with elevated gamma will be cover with a minimum medium/coarse till borrow thickness of 0.5m.
 2. Catchment 3 is a wet muskey area with thick vegetation and no access. Gamma cover not proposed in this area.
 3. Covers for the Tailings completed by O'Kane Consultants Inc.

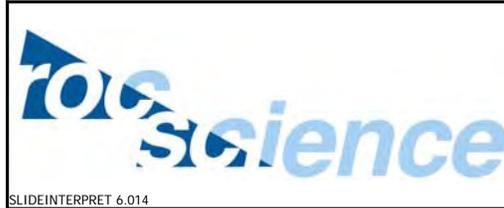
Material Name	Color	Unit Weight (kN/m3)	Strength Type	Cohesion (kN/m2)	Phi	Water Surface
Lake Bed Sediments		20	Mohr-Coulomb	0	25	Water Surface
Bed Rock		25	Infinite strength			None
Waste Rock		22	Mohr-Coulomb	0	45	Water Surface
Sand & Gravel		21	Mohr-Coulomb	0	35	Water Surface
Sand Cover		20	Mohr-Coulomb	0	30	Piezometric Line 1

Project			
Model 4 - South Waste Rock Pile (Gunnar Mine Site Remediation Project)			
Analysis Description			
4.7 5.0H:1.0V slope, elevated water table, LBS $\phi' = 25^\circ$ (upper bound sensitivity check) (Pseudo-static - PGA = 0.031)			
Drawn By	R Williams	Scale	1:950
		Company	SRK Consulting
Date	6/15/2016, 3:52:16 PM		File Name
			4.7 - Seismic.slim

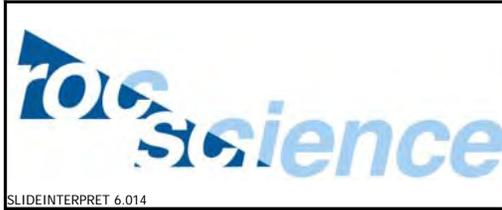
Material Name	Color	Unit Weight (kN/m3)	Strength Type	Cohesion (kN/m2)	Phi	Water Surface
Lake Bed Sediments		20	Mohr-Coulomb	0	25	Water Surface
Bed Rock		25	Infinite strength			None
Waste Rock		22	Mohr-Coulomb	0	50	Water Surface
Sand Cover		20	Mohr-Coulomb	0	30	Piezometric Line 1

Project			
Model 5 - East Waste Rock Pile (Gunnar Mine Site Remediation Project)			
Analysis Description			
5.7 5.0H:1.0V slope, elevated water table, LBS $\phi' = 25^\circ$ (upper bound sensitivity check) (Pseudo-static - PGA = 0.031)			
Drawn By	R Williams	Scale	1:450
Company	SRK Consulting		
Date	6/15/2016, 3:52:16 PM		File Name
			5.7 - Seismic.slim

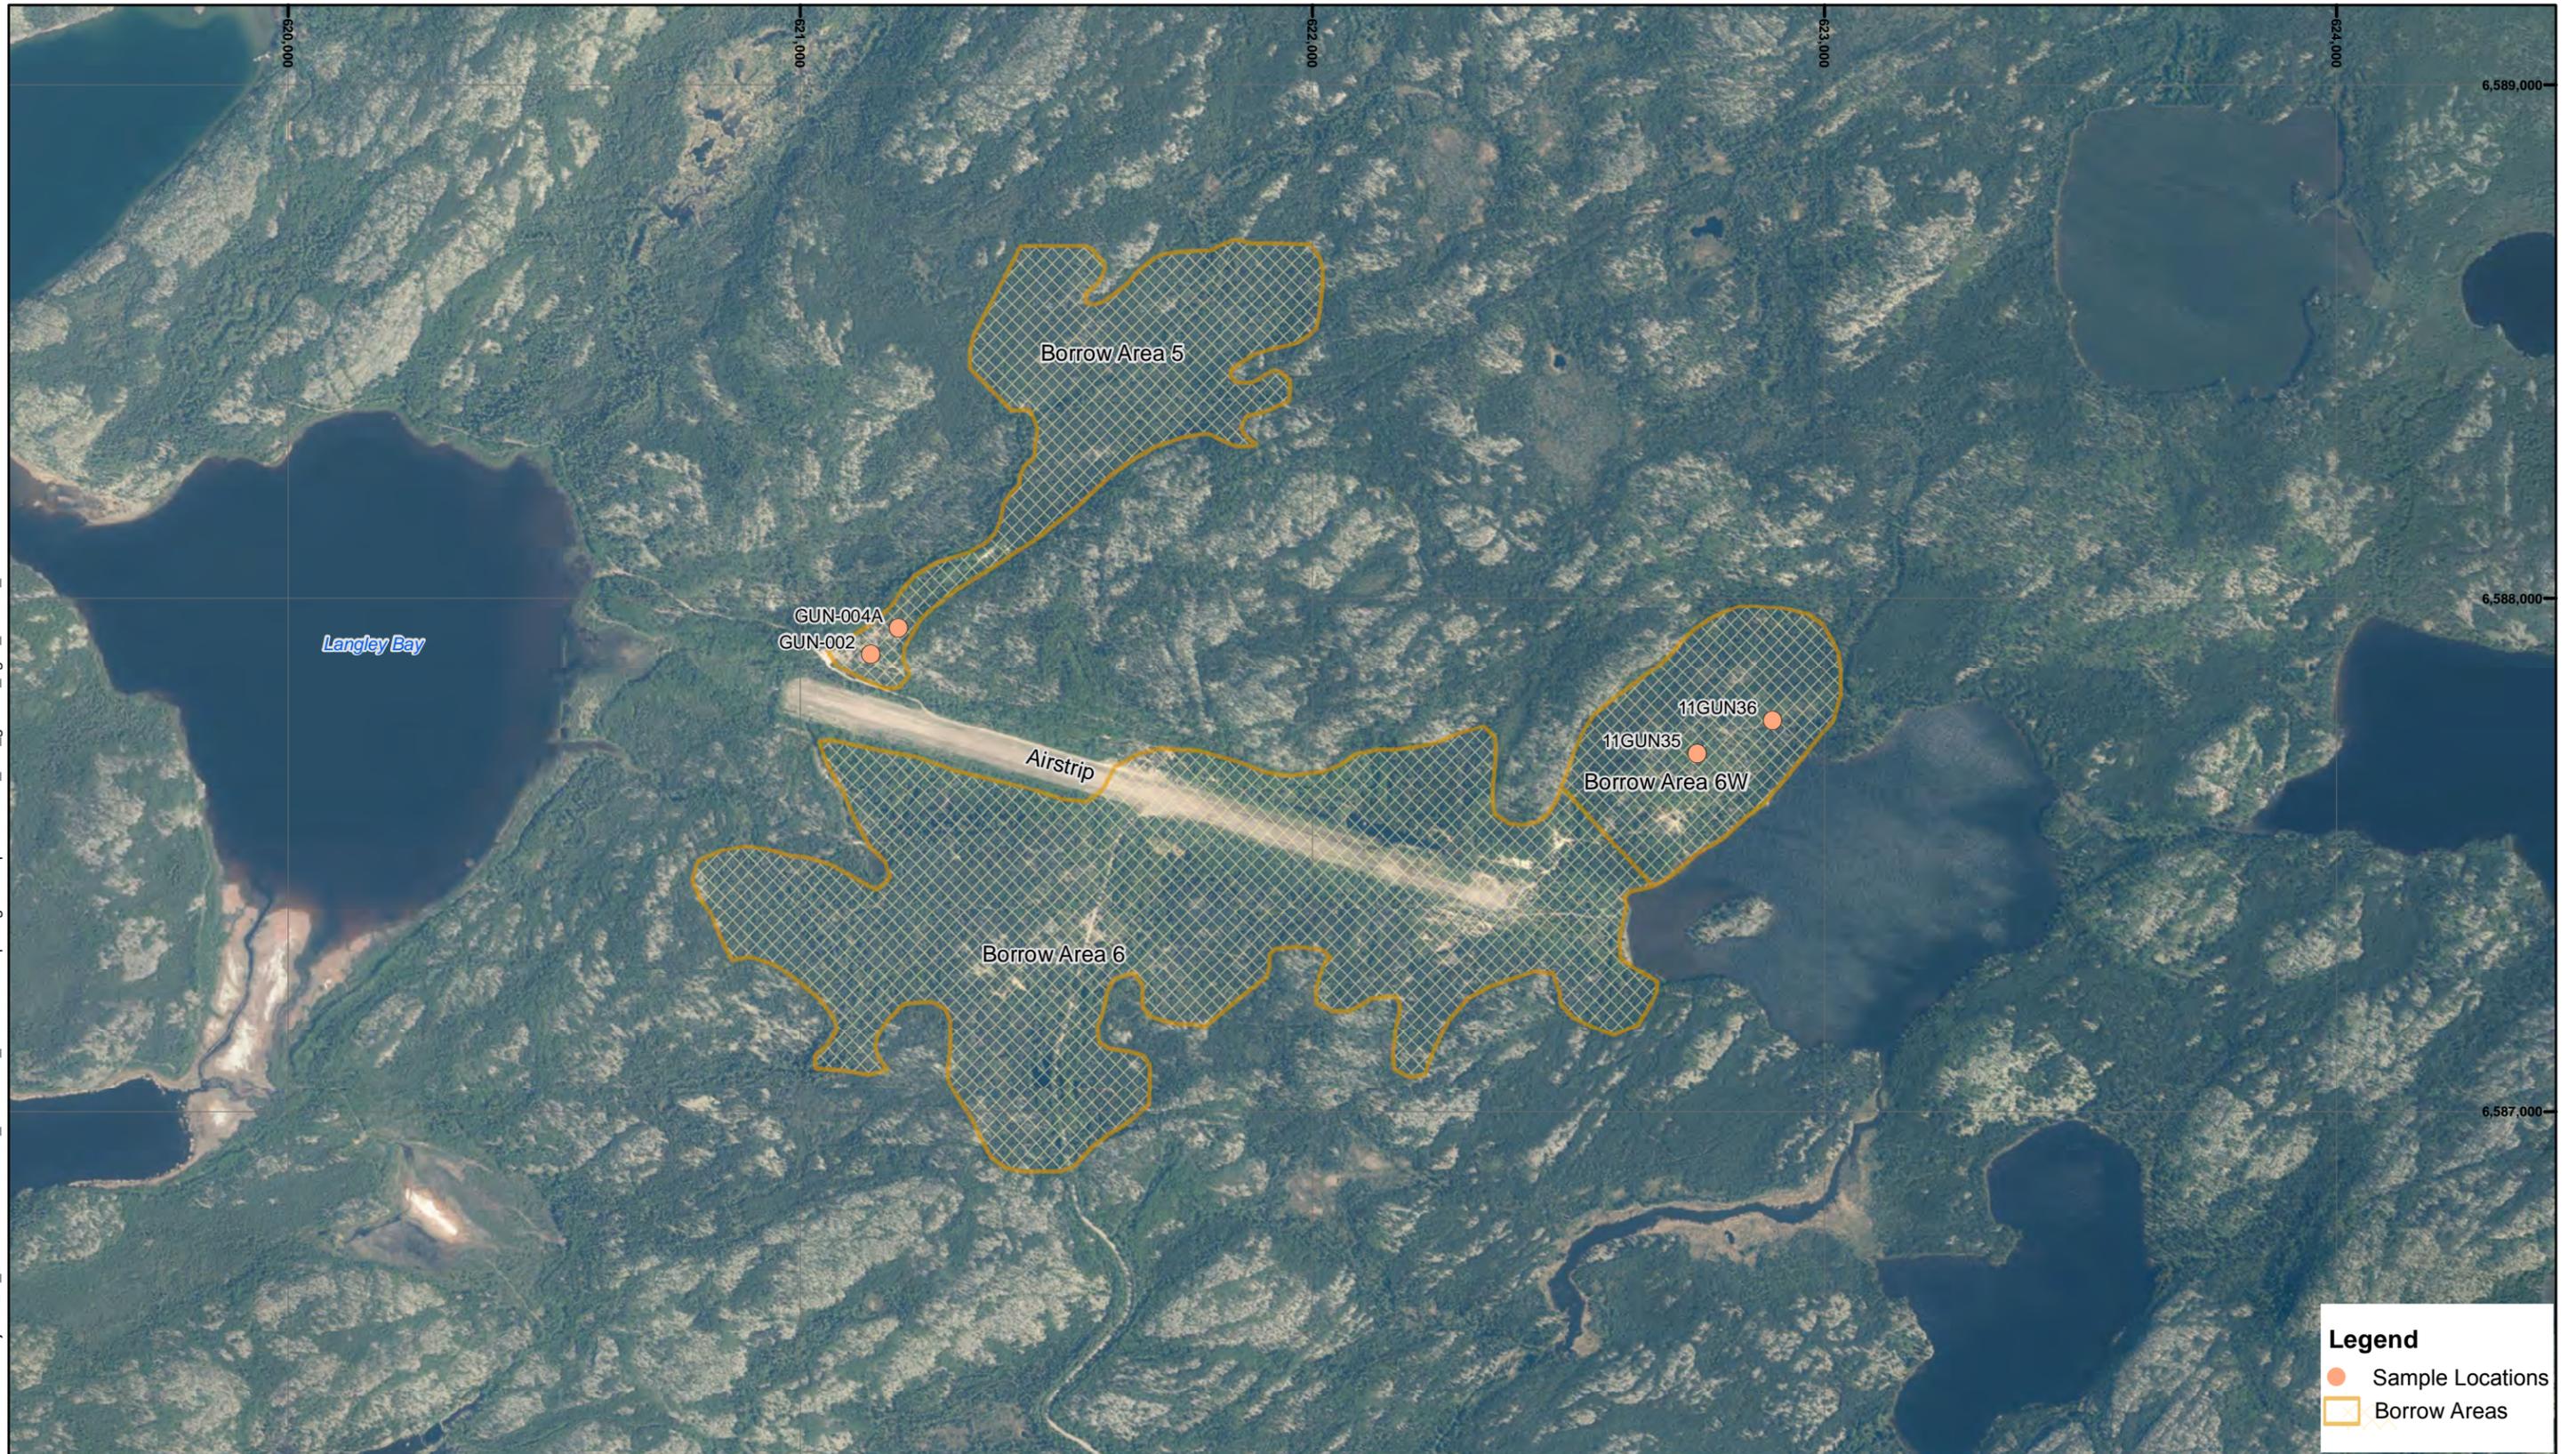
- Sample Locations
- Borrow Areas

Three representative soils from the August, 2015 field sample program (O’Kane, 2015) were also evaluated separately using the soil erodibility nomograph: a coarse textured soil, a medium-coarse textured soil, and a medium-fine textured soil, all from Borrow Area 5. SRK understands that it is unlikely that this material will be used for the “other site aspects”; however, the soils were assessed to determine how borrow from a different area would compare to that of Borrow Area 6W. The K values were 0.027, 0.038 and 0.099, respectively.
