CNSC COMMISSION MEMBER DOCUMENT (CMD)

CMD 16-H6.1

WNSL Phase II hold point release to proceed with the Gunnar Remediation Project
"Other Site Aspects"

Saskatchewan Research Council

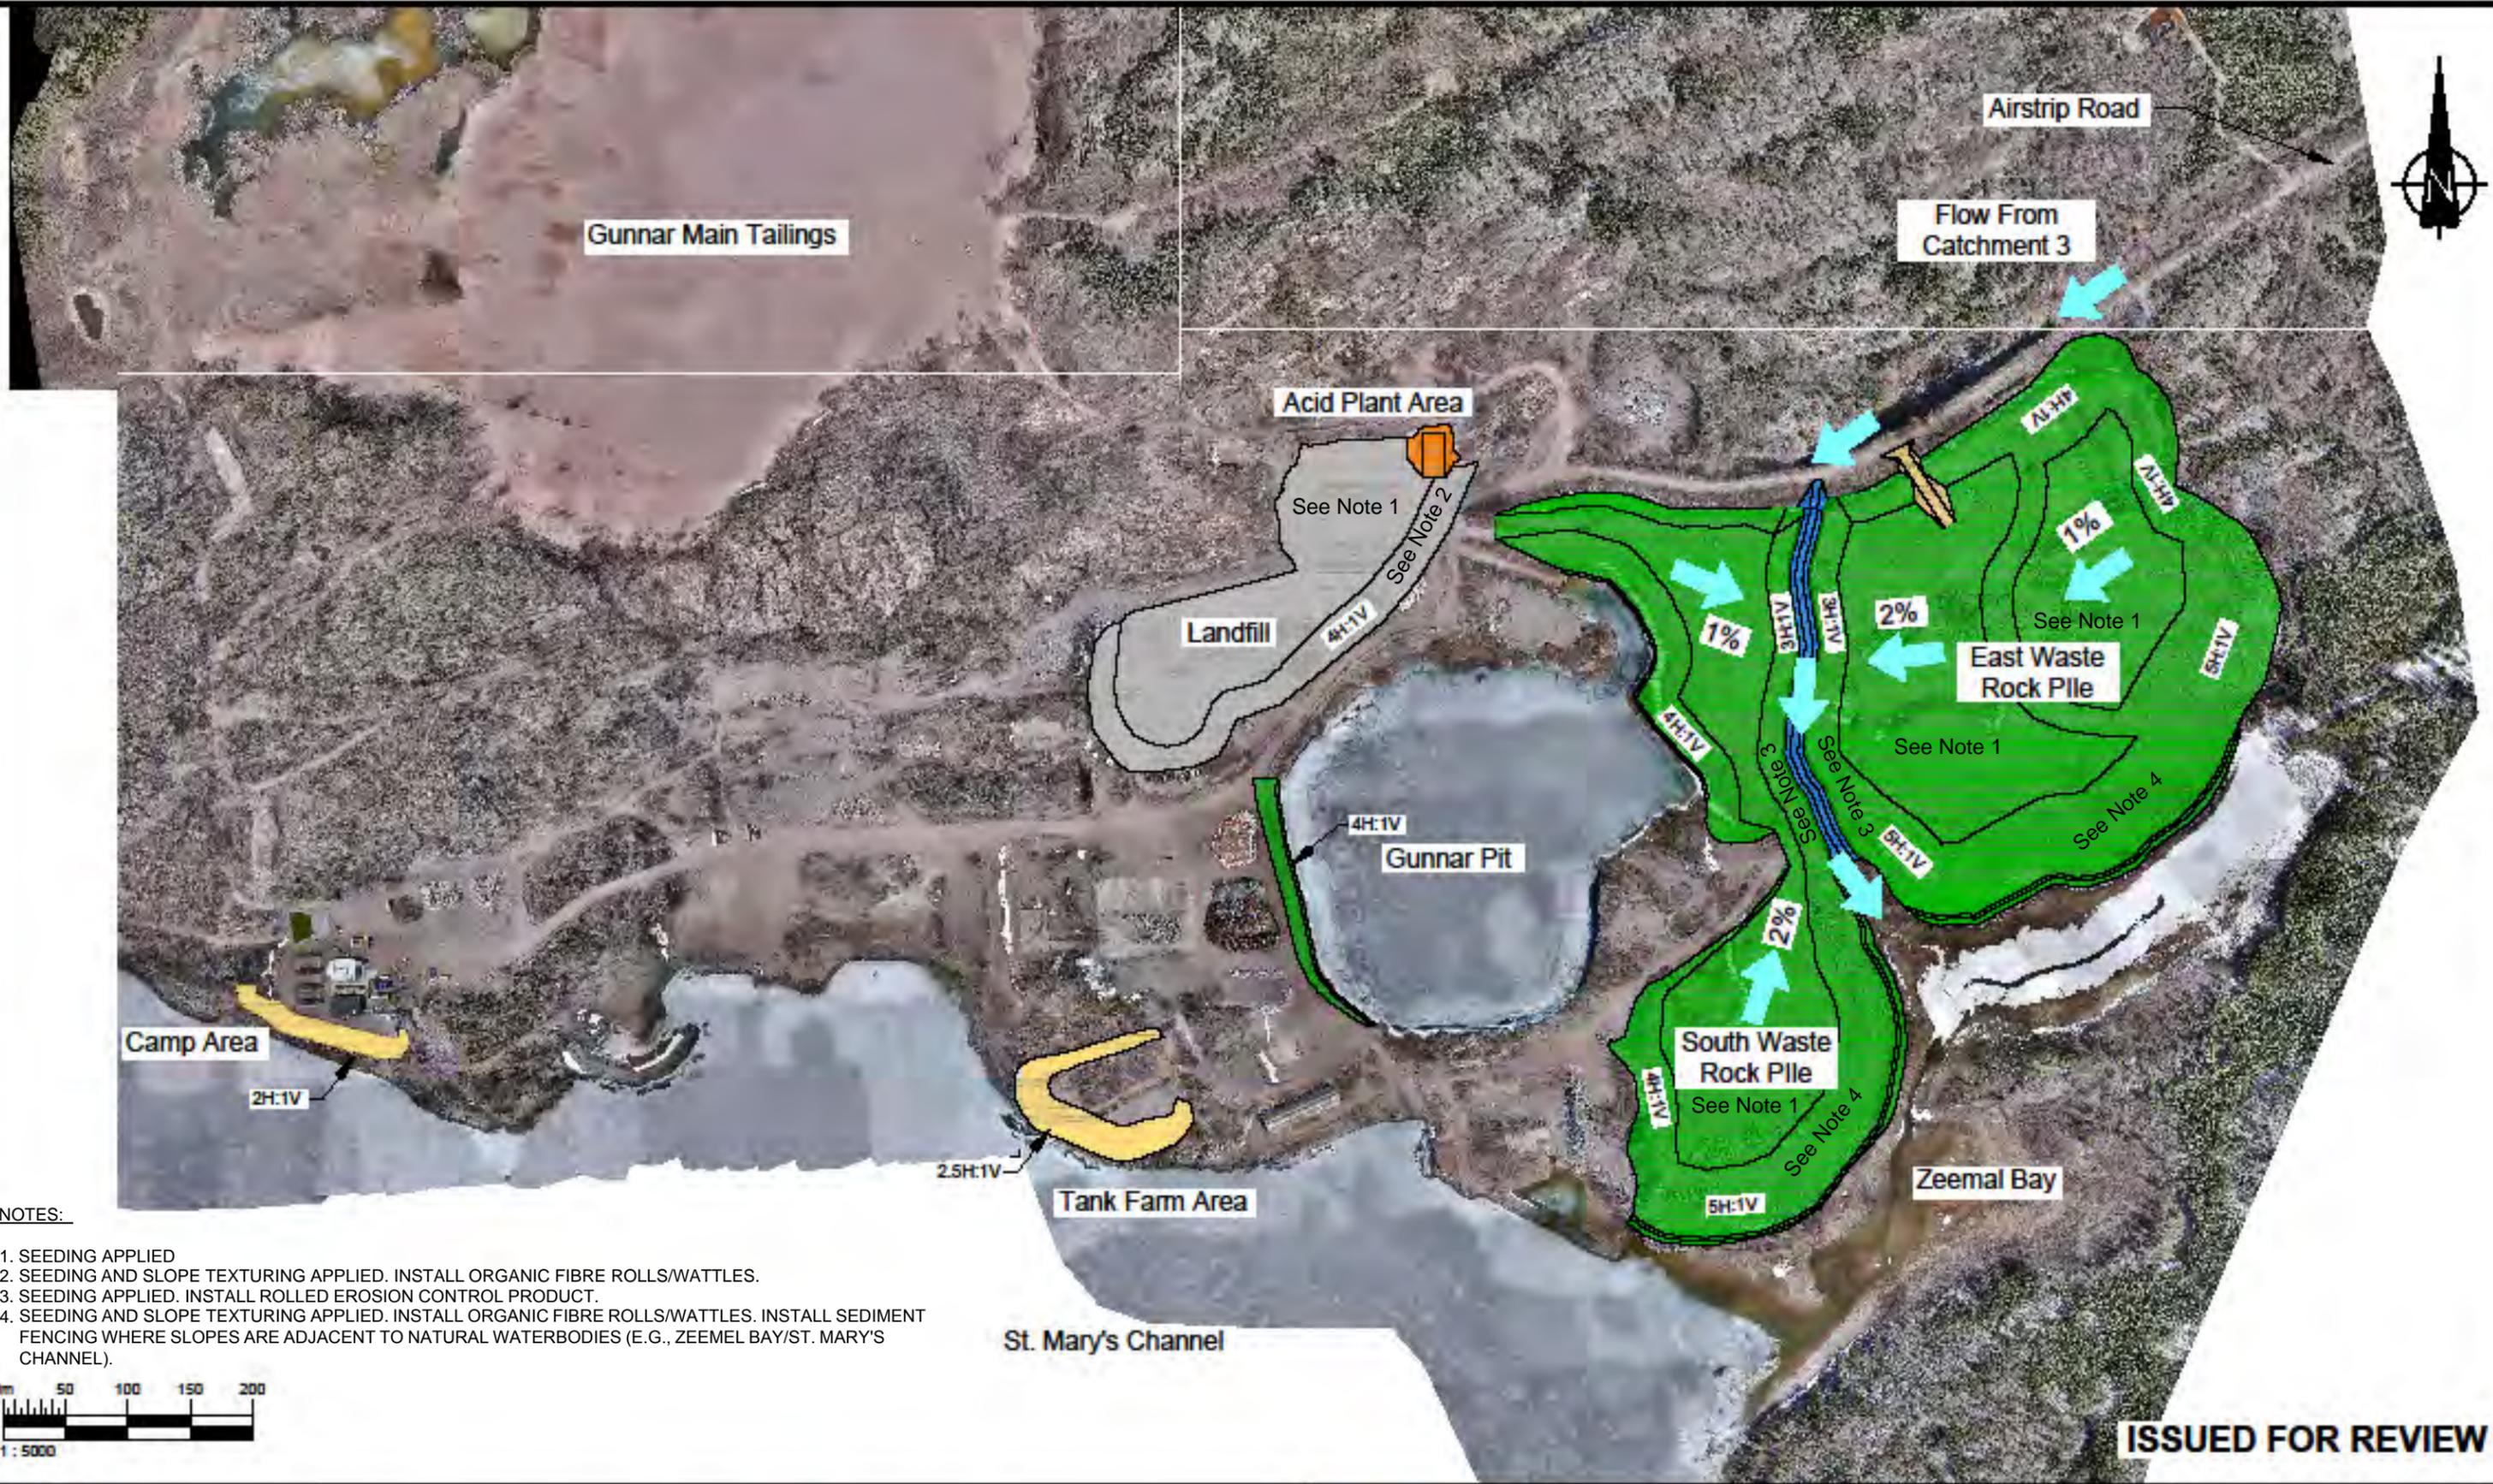
1. SEEDING APPLIED
2. SEEDING AND SLOPE TEXTURING APPLIED. INSTALL ORGANIC FIBRE ROLLS/WATTLES.
3. SEEDING APPLIED. INSTALL ROLLED EROSION CONTROL PRODUCT.
4. SEEDING AND SLOPE TEXTURING APPLIED. INSTALL ORGANIC FIBRE ROLLS/WATTLES. INSTALL SEDIMENT FENCING WHERE SLOPES ARE ADJACENT TO NATURAL WATERBODIES (E.G., ZEEMEL BAY/ST. MARY'S CHANNEL).
