Saskatchewan Research Council

Gunnar Mine Site Closure Options
November 16, 2010

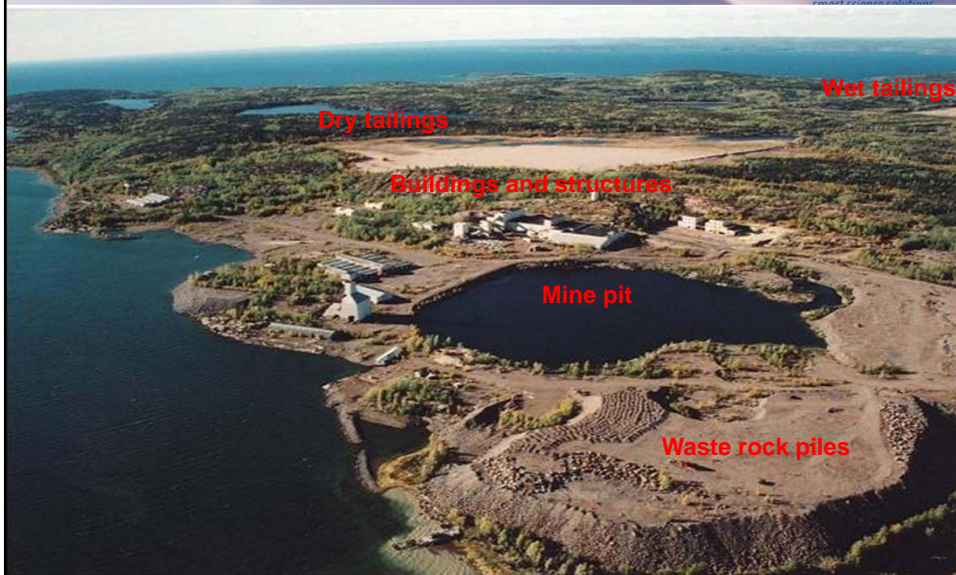
Gunnar site components

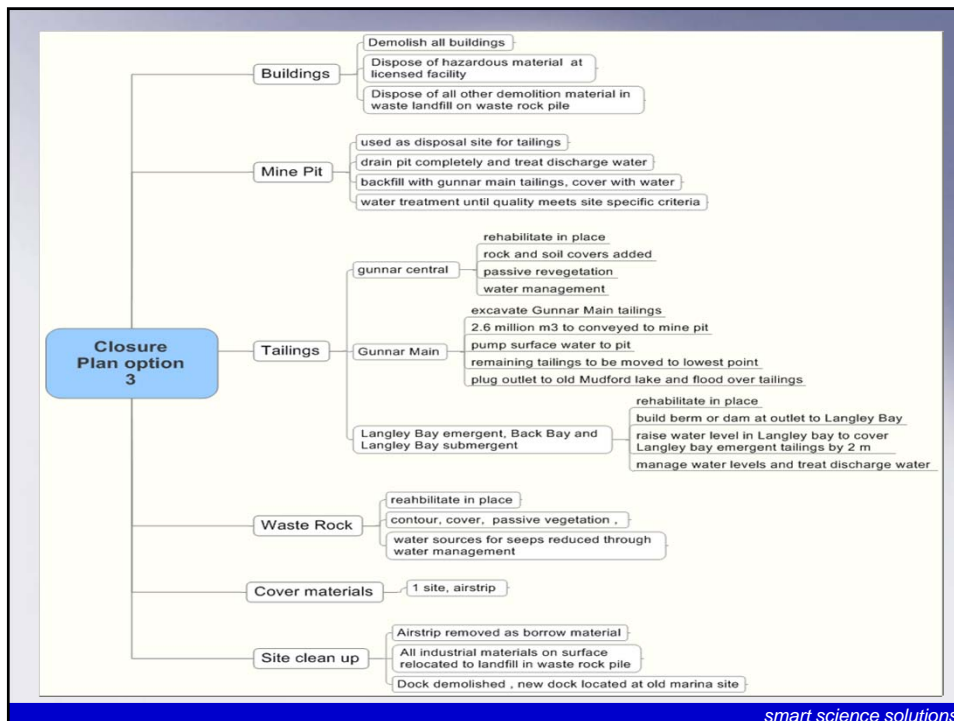
Closure option #3

- **Mine pit:**
 - Drain to Athabasca Lake following water treatment
 - Use it for disposal of the tailings & demolition waste
 - Cover and re-vegetate
- **Waste rock**
 - Clean-up, contour, cover, and re-vegetate
 - Divert water flows feeding the seep
- **Dry tailings**
 - Gunnar main: dispose in the mine pit
 - Central and Langley Bay:
 - Cover and re-vegetate
 - Divert/channelize surface water flows

- **Pro:**
 - Eliminates public hazards due to the mine pit,
 - Eliminates discharge from the mine pit
 - Eliminates environmental hazards from Gunnar main tailings
- **Con**
 - Footprint of Gunnar Main is to be covered and revegetated
 - Remaining tailings are to be covered and revegetated
 - Will need perpetual water treatment for residual seep from the waste rock
 - Will need a landfill to dispose demolition hazardous wastes
 - Higher occupational hazards during remediation work (due to pit dewatering, and tailing excavation and relocation)
 - Pit water treatment is expensive and may take 3-4 years
 - The highest capital and operational (maintenance) cost
